SUBJECT: Arborist Field Observation Reports, Wood Line Break

Arborist Field Observation Report - 1

Project: Southern Water District, Wood Line Break Oaks
Date: December 18, 2014
Start: 7:00 AM
End: 11:30 AM

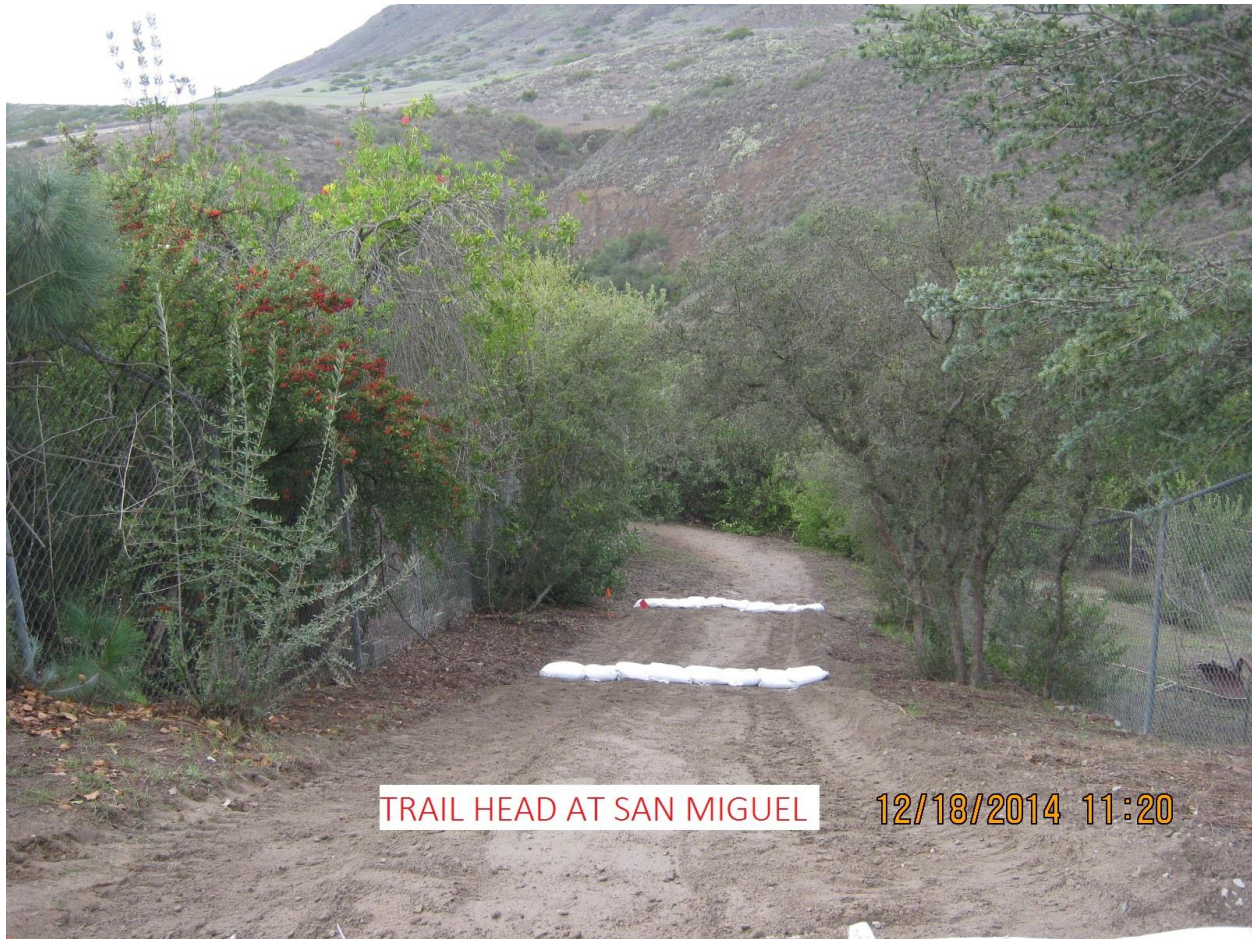
Photo 1-1

Above: Looking west at covered steps at the San Miguel Ct. trailhead. This is the ingress route for some construction equipment.

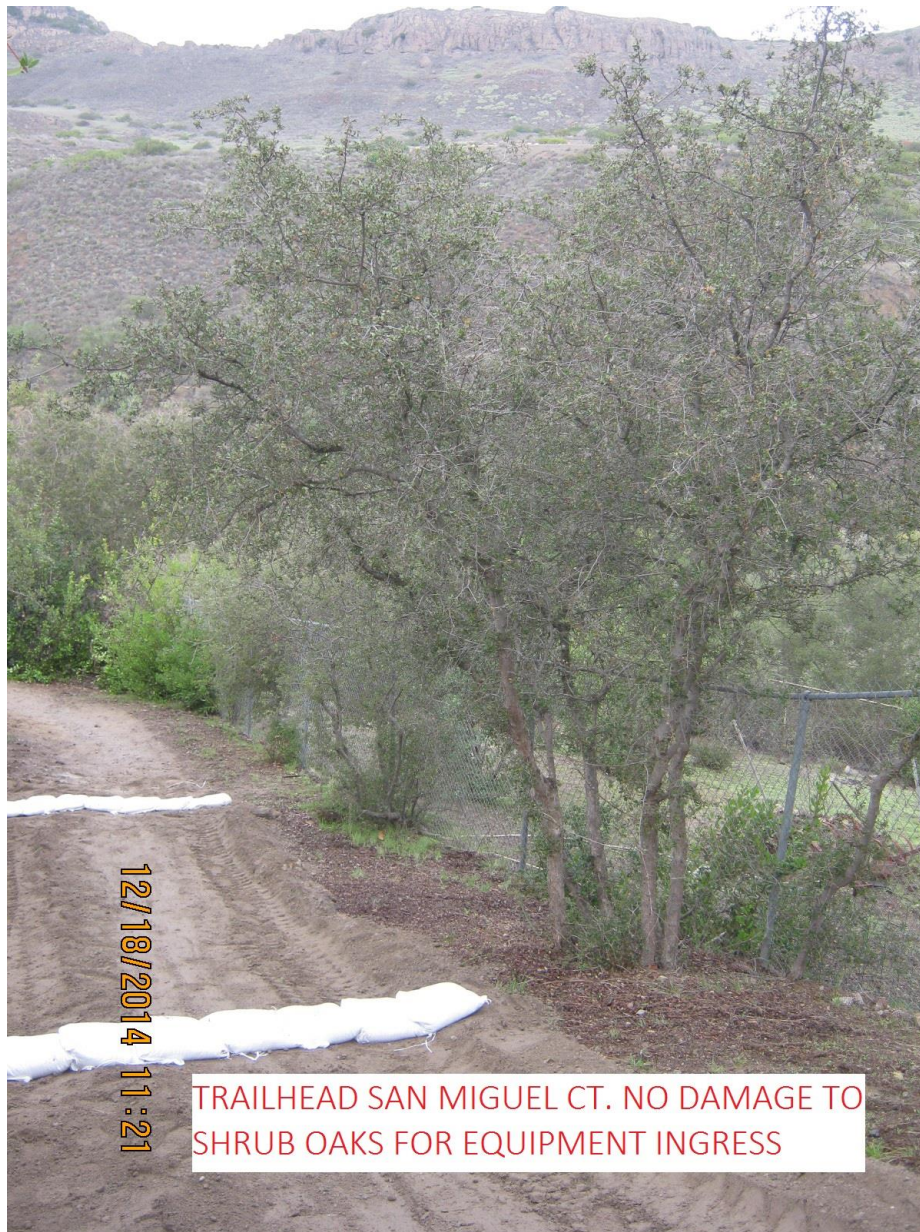
Photo 1-2

Above: Looking west at covered steps at the San Miguel Ct. trailhead.

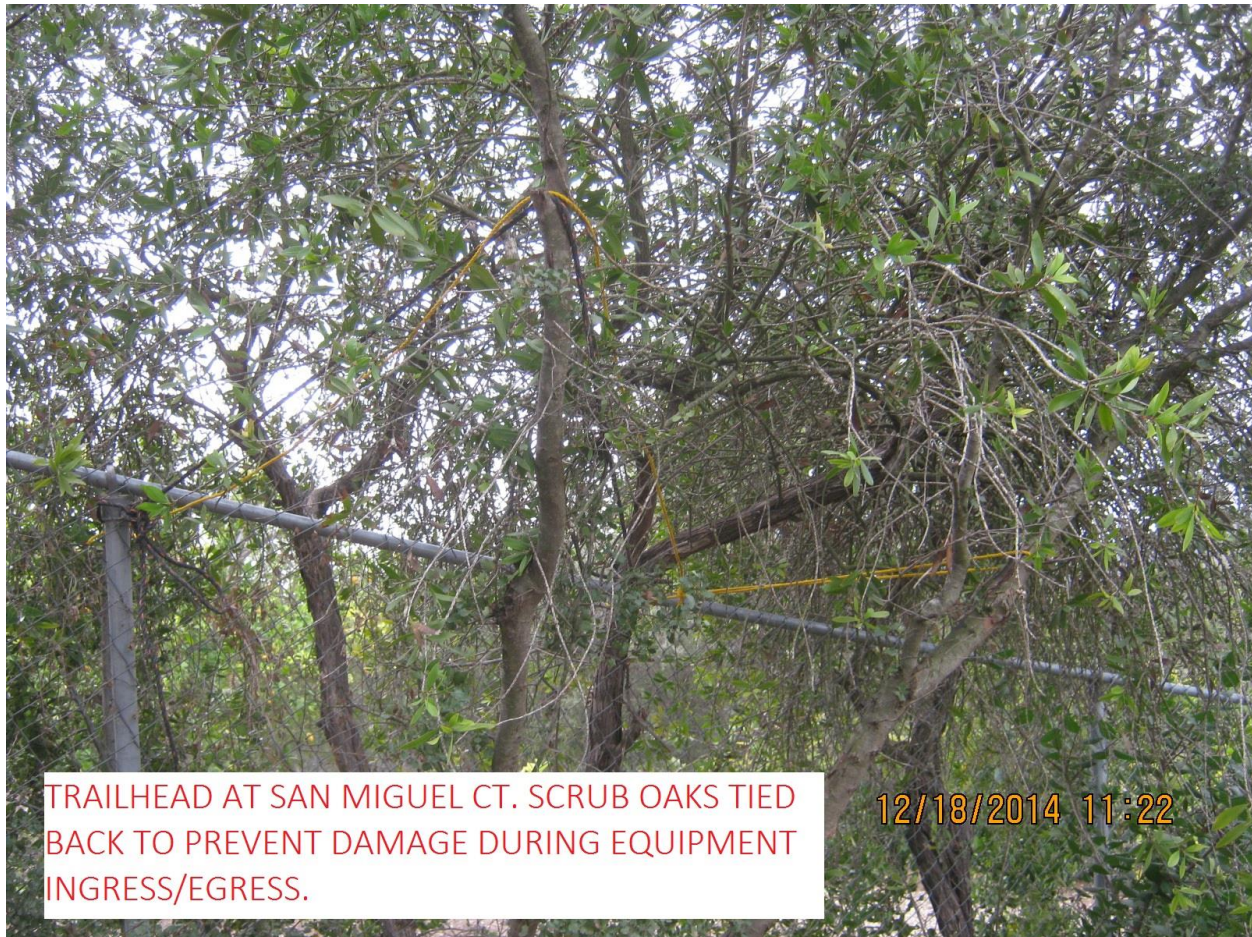
Photo 1-3

Above: scrub oaks at the San Miguel Ct. trailhead.

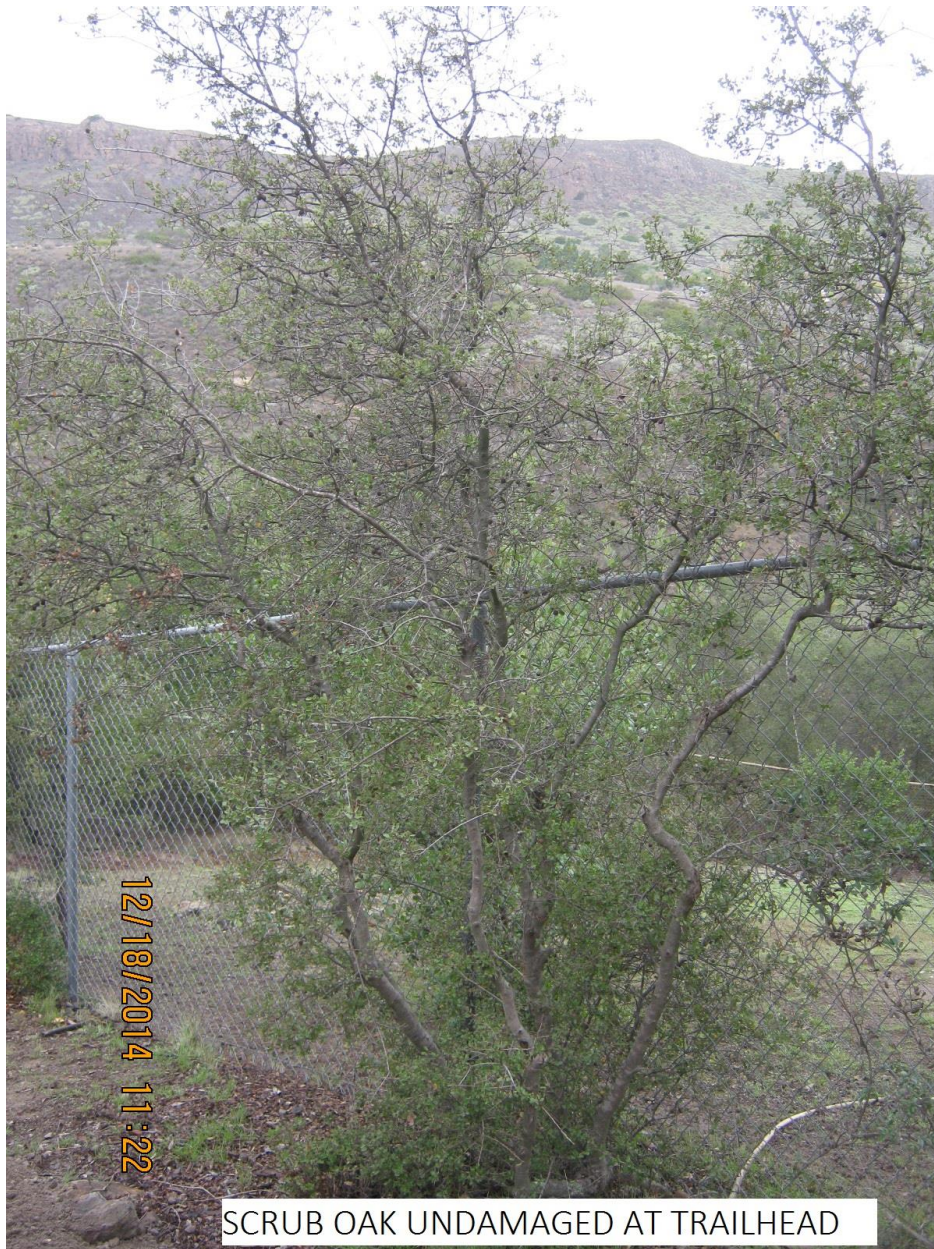
Photo 1-4

Above: scrub oaks at the San Miguel Ct. trailhead.

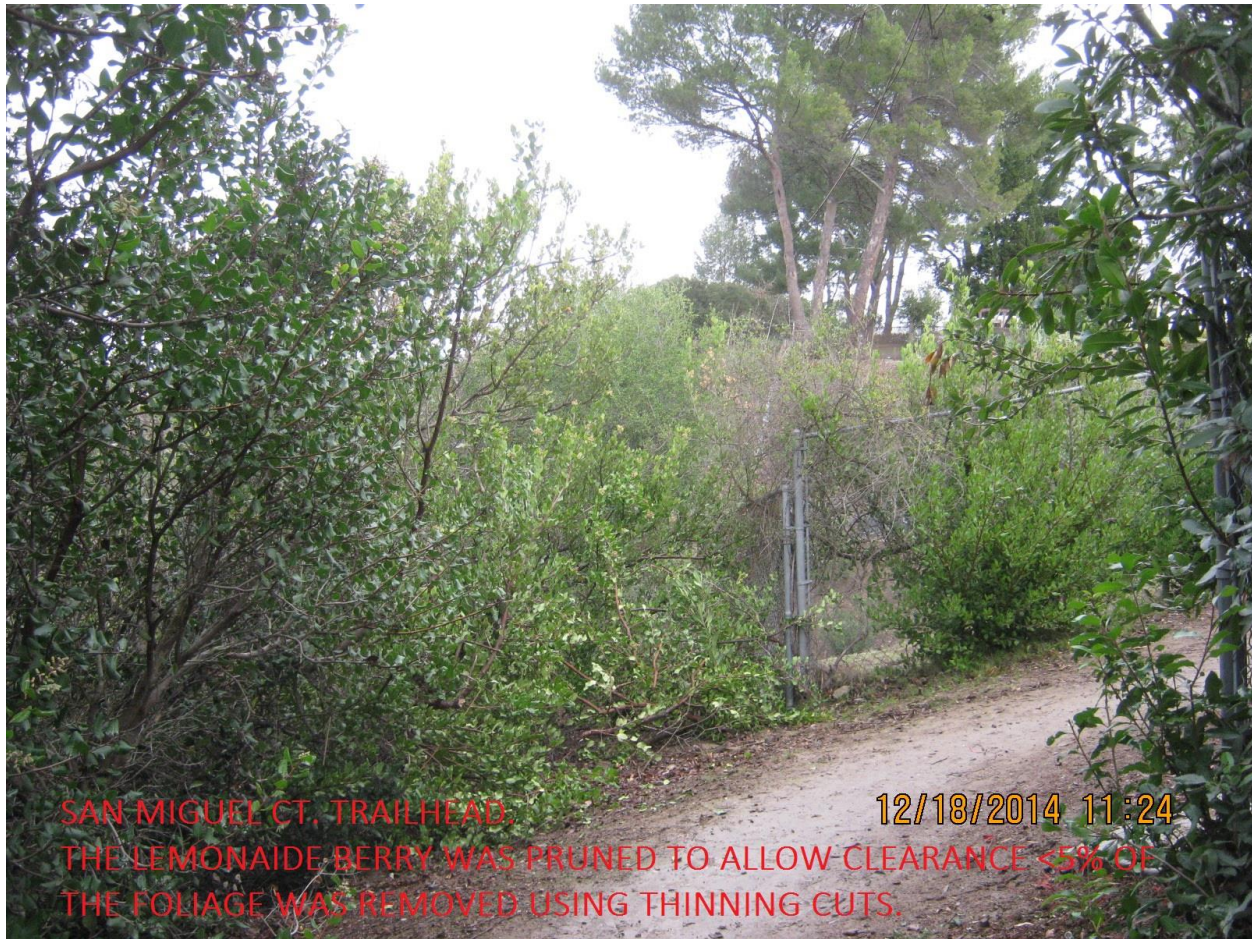
Photo 1-5

Above: San Miguel Ct. trailhead.

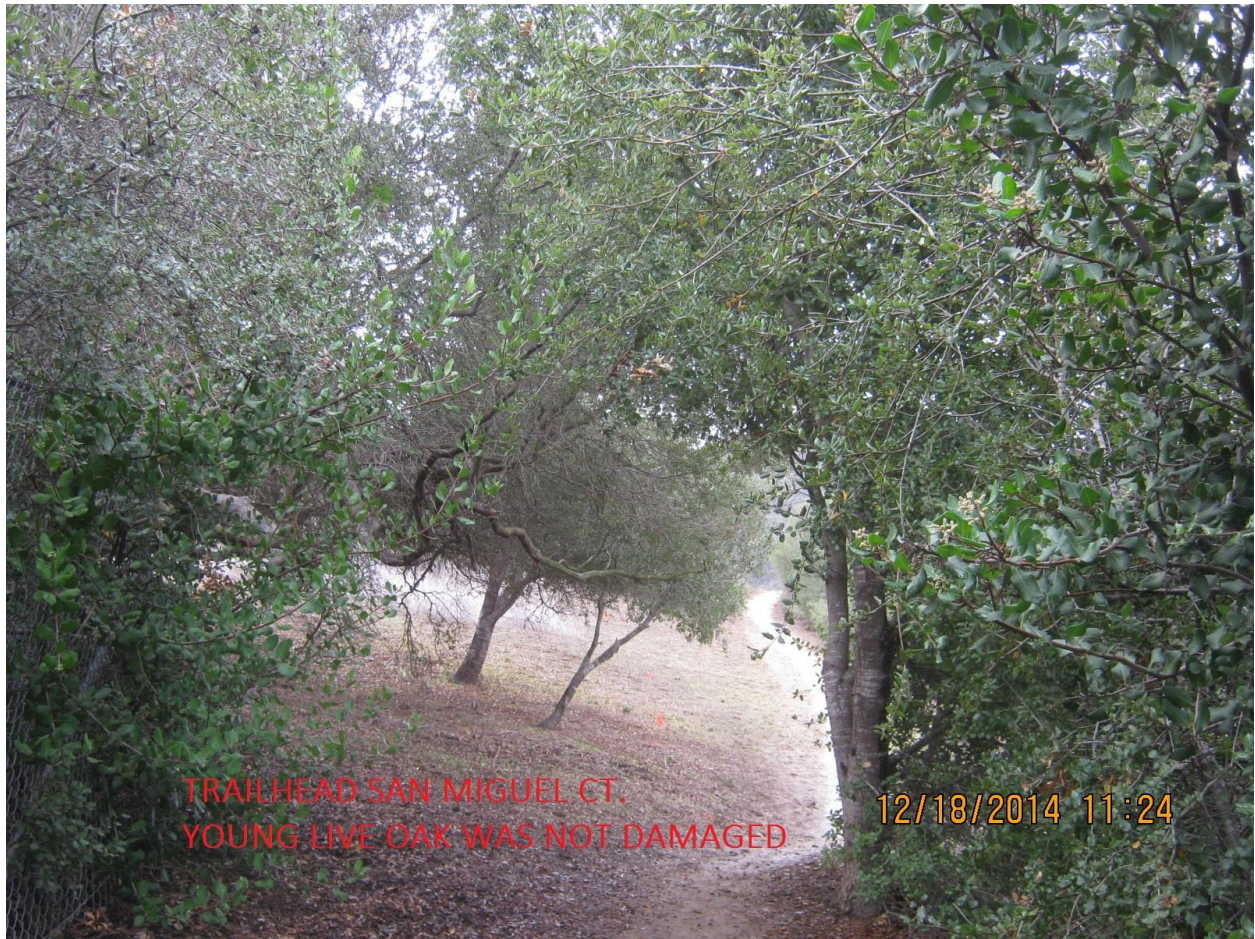
Photo 1-6

Above: San Miguel Ct. trailhead.

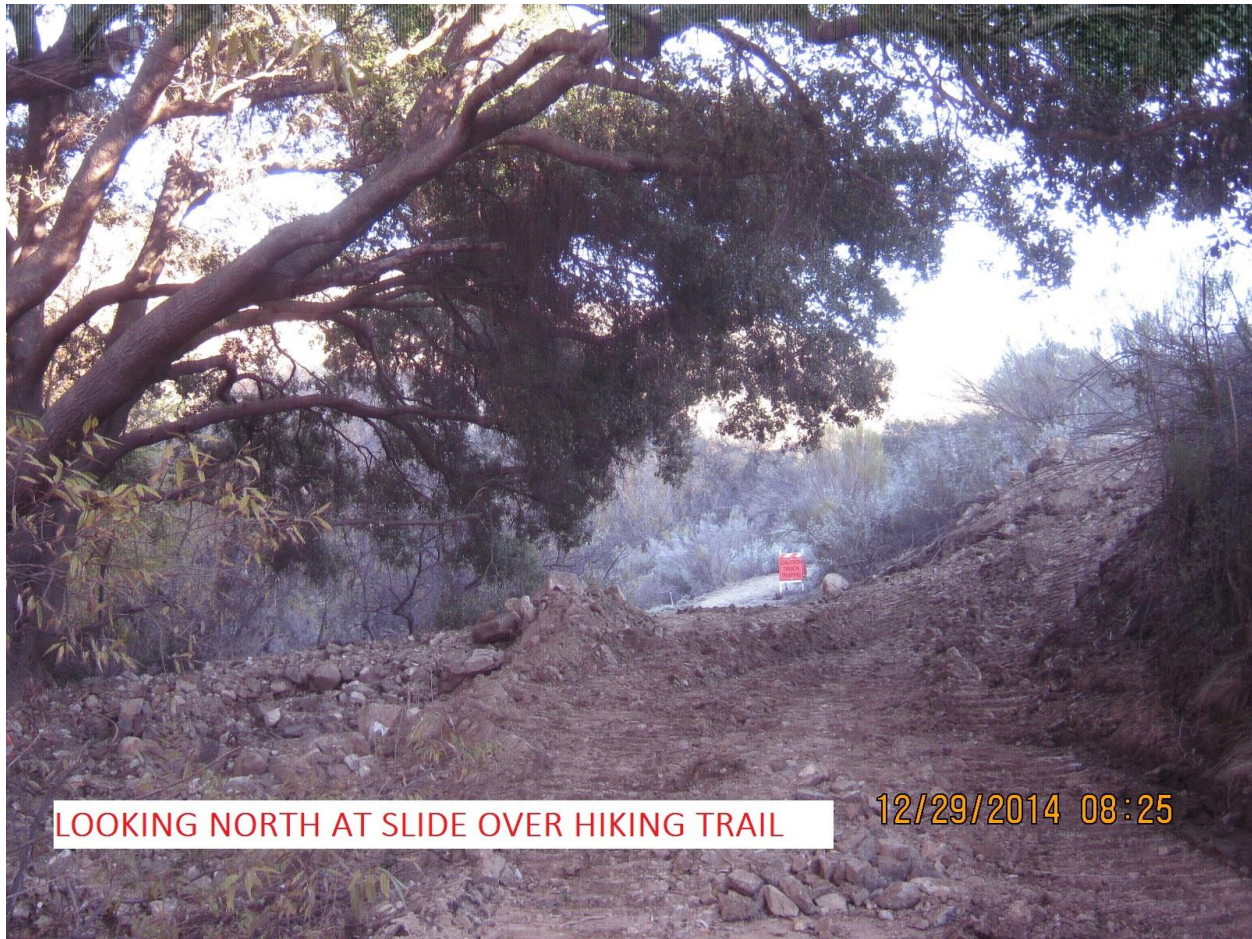
Photo 2-1

Above: Looking north on trail beside 2 oaks at Wood Park.

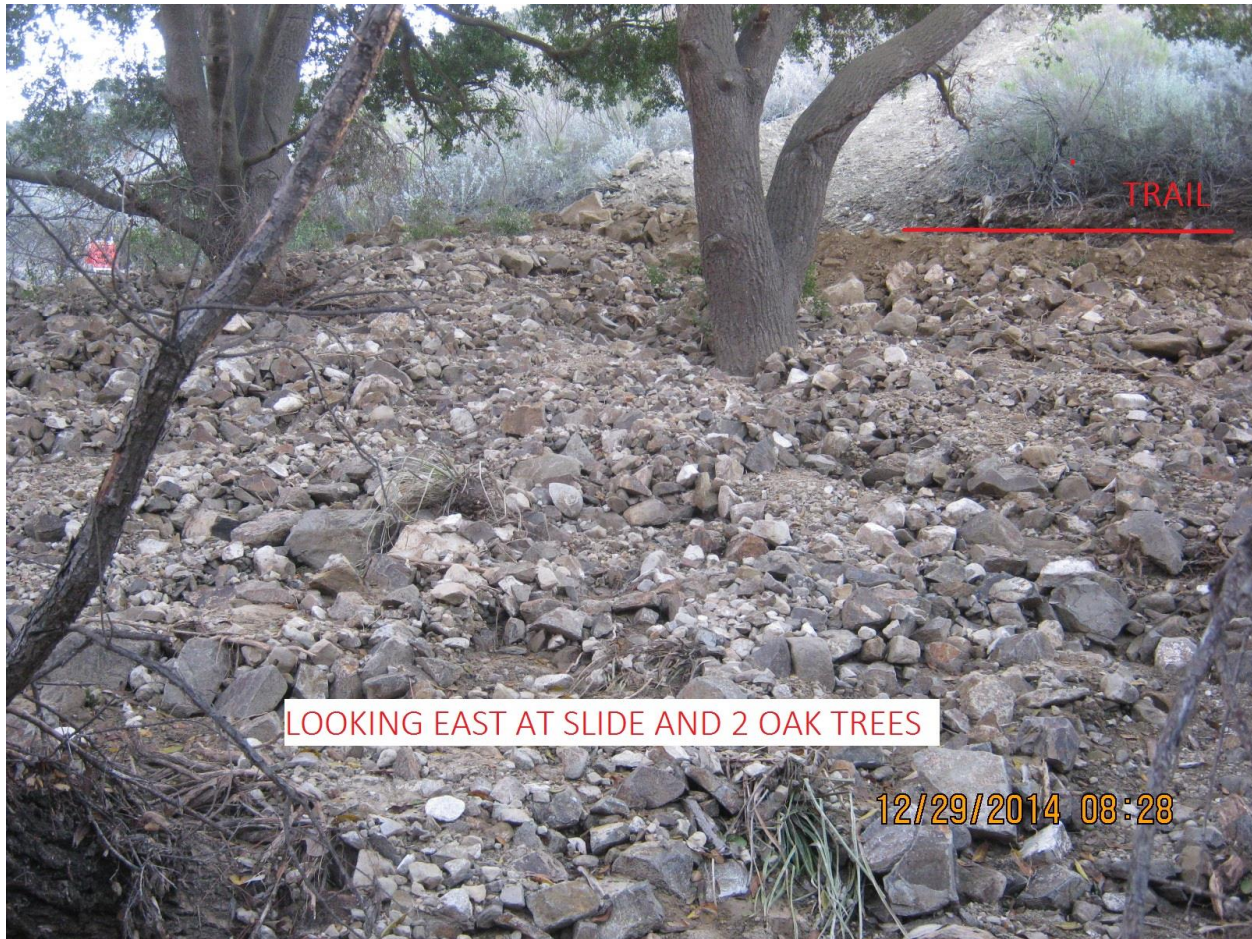
Photo 2-2

Above: Looking east at slide.

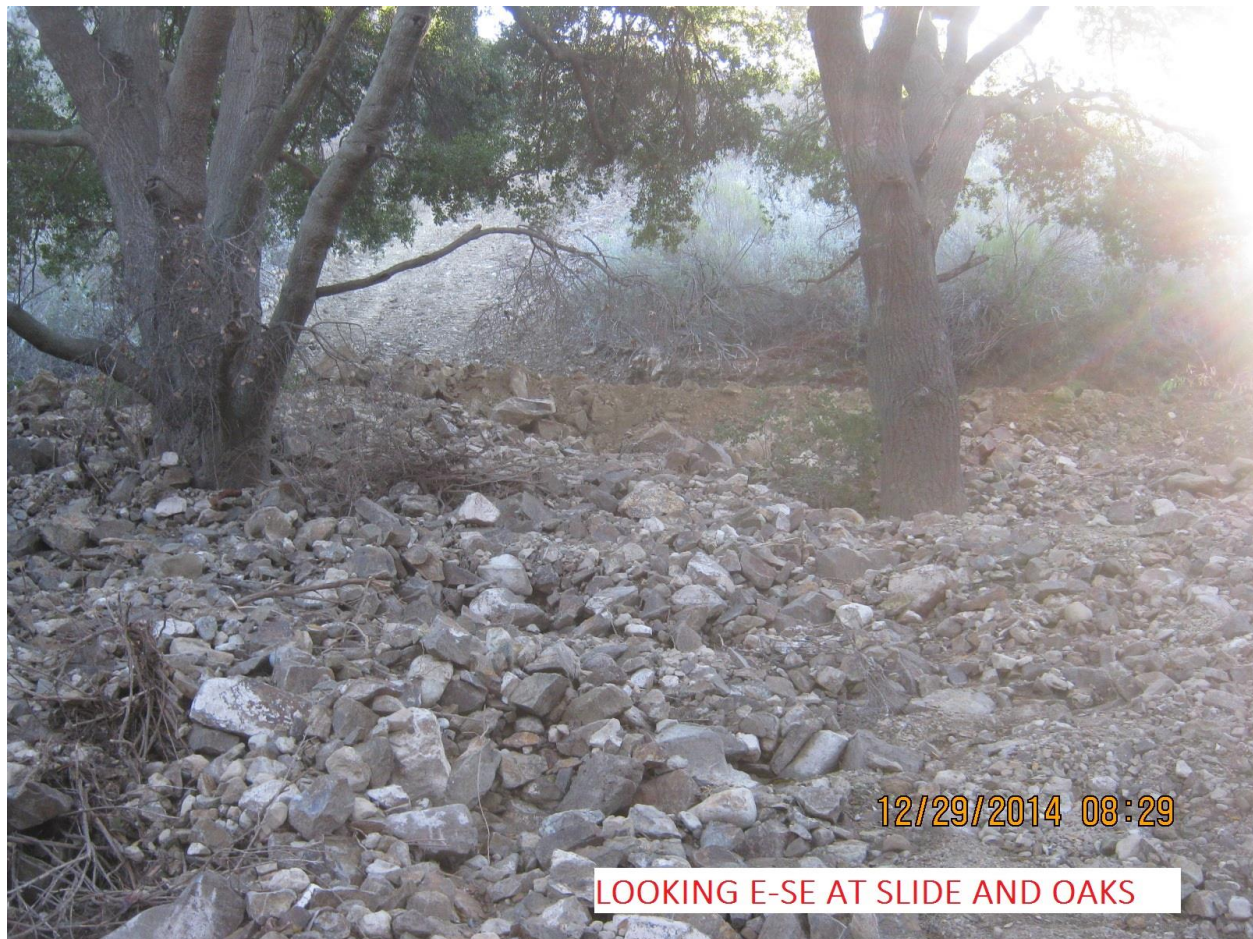
Photo 2-3

Above: Looking east at slide.

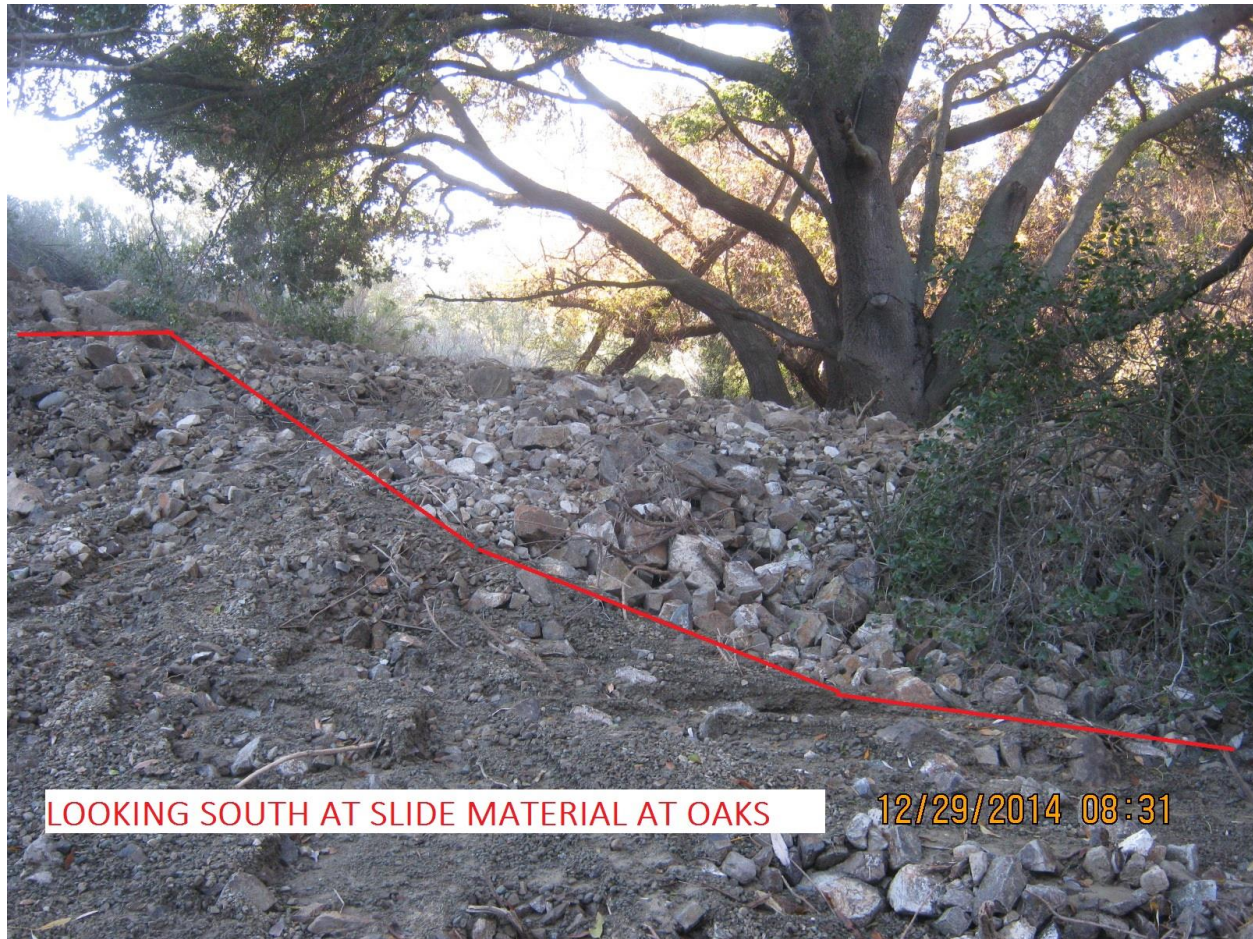
Photo 2-4

At the bottom of the slide I saw two mature oak trees one with a 42" DBH (diameter at breast height) and another with a 30" DBH. The slide material includes soil and boulders and had piled up to over 5 feet at the deepest point. Near the edge of the oak canopies the slide tapered off to natural grade.

Above: Looking south at 5' of slide material under oak trees.

I explained to Art that they should try to remove all the fill below the oak canopies and restore the pre-slide grade as much as possible given the damage caused by the slide.

The material within 3 feet of the trunk was to be removed using hand tools to avoid damaging the trunk. The same use of hand tools was agreed to around a partially buried scaffold branch.

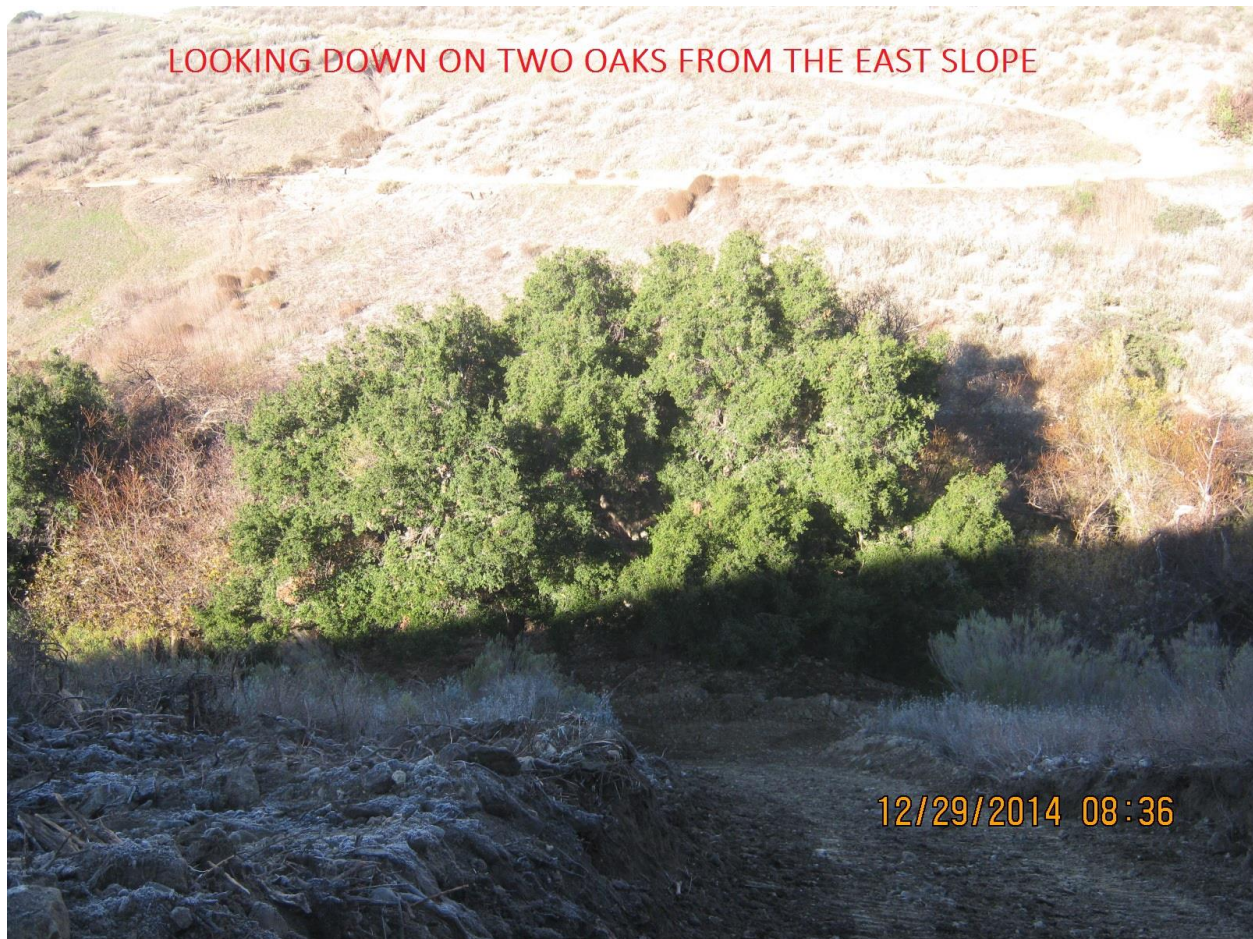
Photo 2-5

Above: looking west and down at slide and oak trees.

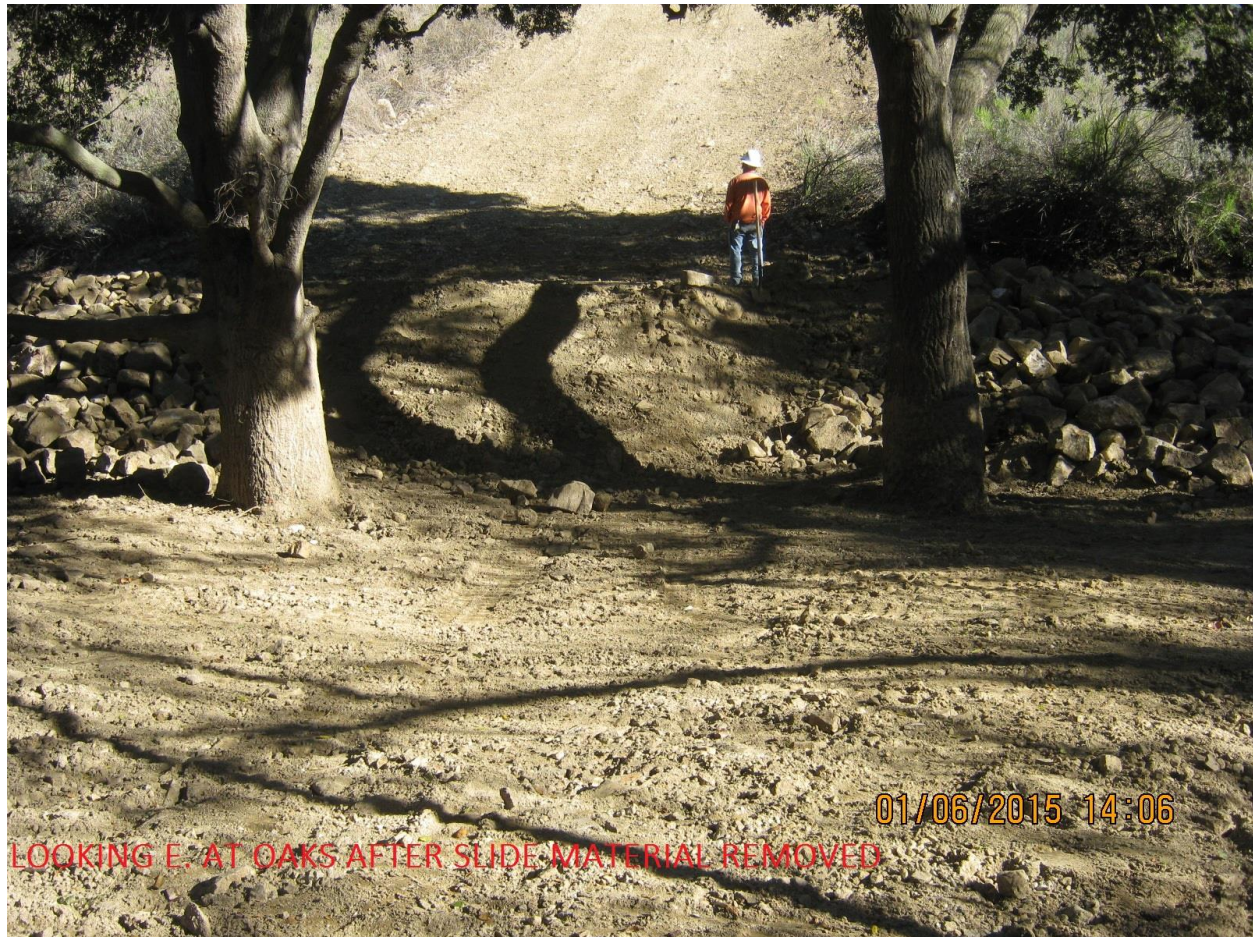
Photo 3-1

The slide material had been removed to the base of the oak trees. I was able to observe the trunk flare at the base of both trees.

Above: Looking east at oak trees after slide material removed.

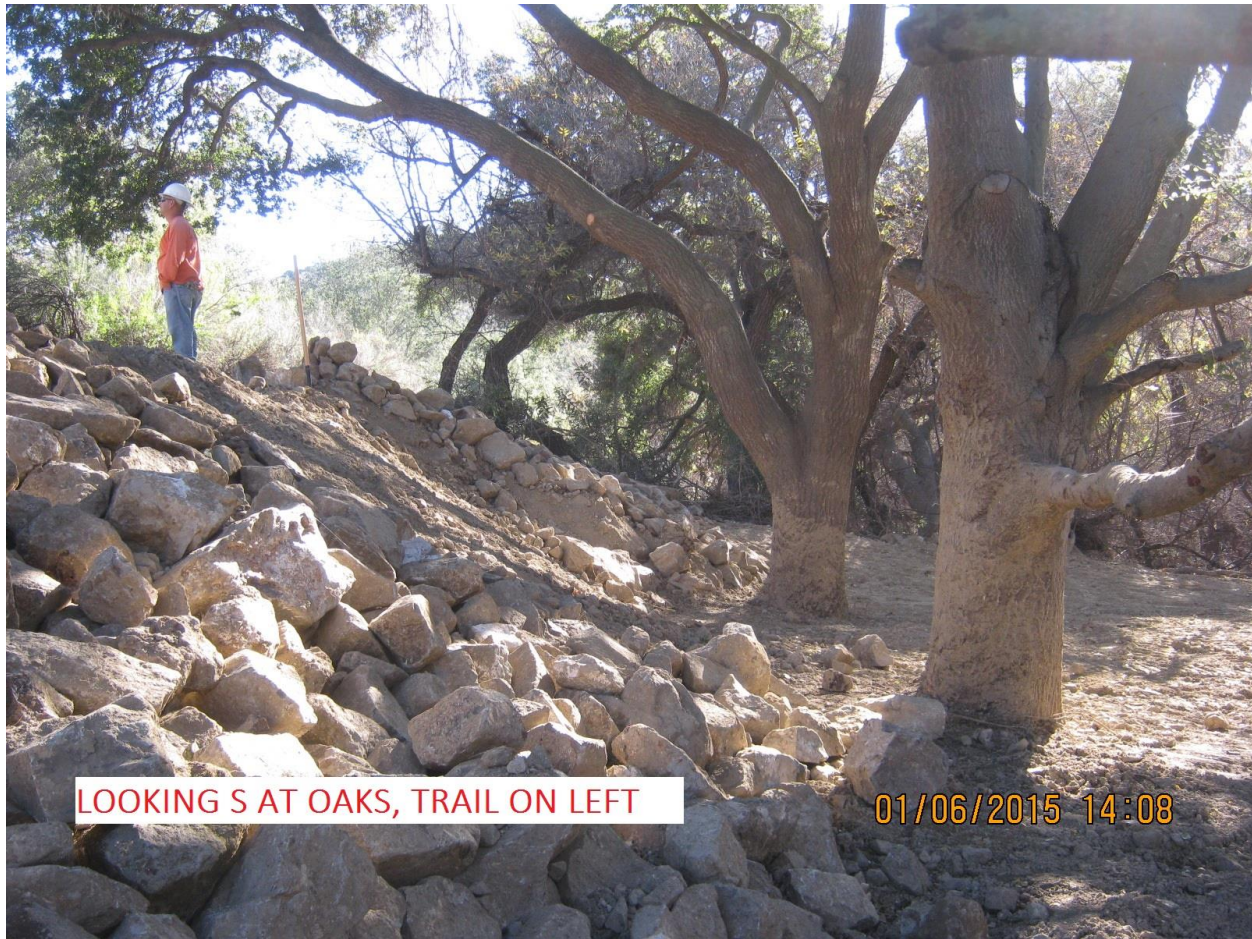
Photo 3-2

Above: Looking south at oak trees after slide material removed.

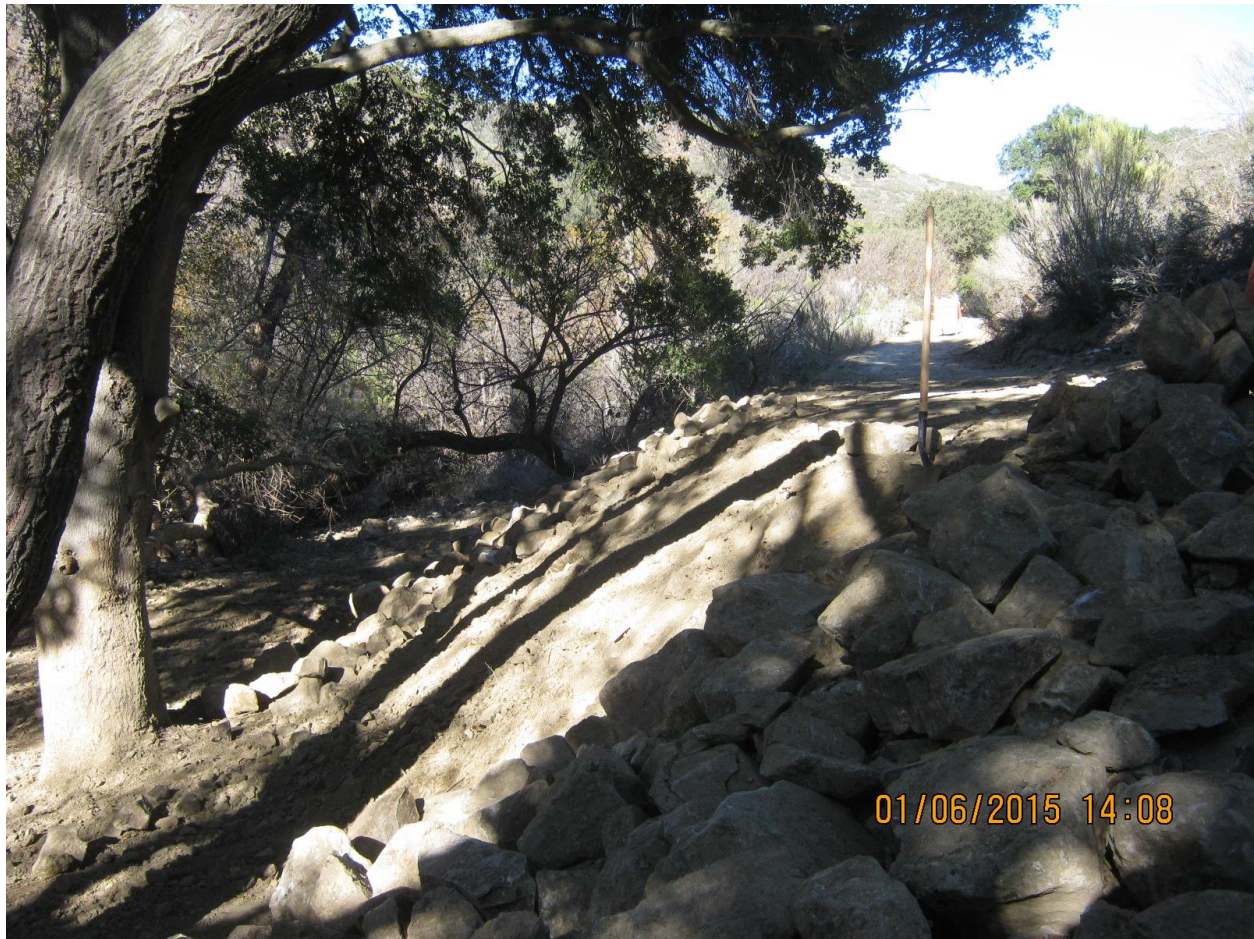
Photo 3-3

The trail had been restored to near its original shape where it passed below the oaks. Boulders from the recent slide had been placed against the slope to reinforce the slope below (west) the trail.

Above: Looking north at oaks and trail after slide material removed.
