## **Tree Report: Impact of home remodel on one coast live oak**

per City of Thousand Oaks Res No 2010014

**M. Client & B. Client**

**April 21, 2015**

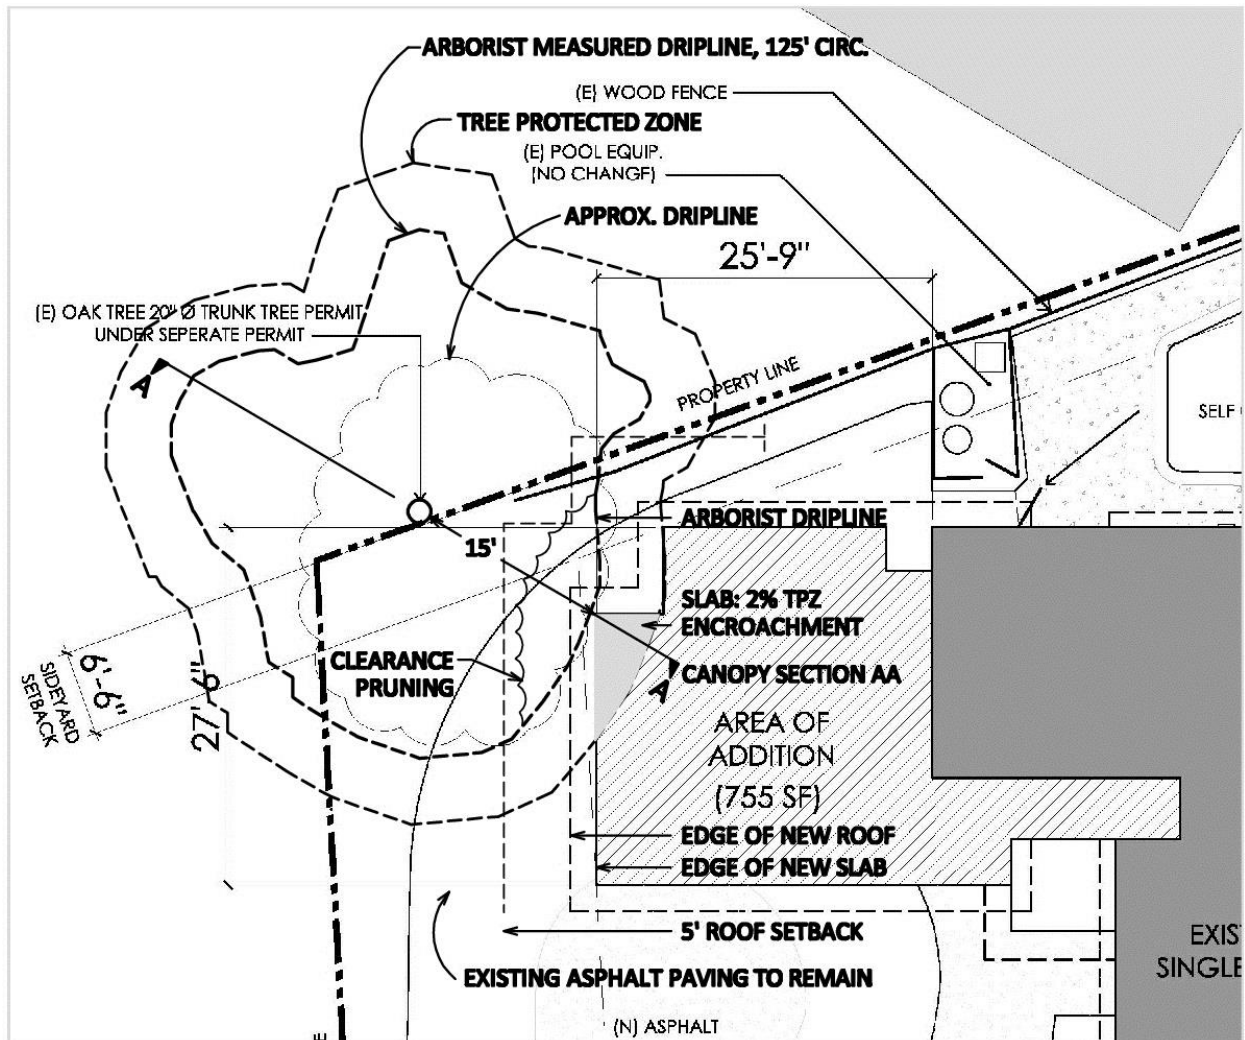
Figure 1 Spatial Study Plan View

Based on the drawings I made the following measurements:

Tree protected Zone	1630 square feet
Excavation in protected zone	27 square feet about 2%
Drip line	125 feet long
Drip line penetration by roof	4 feet or 3%
Drip line penetration by clearance pruning	12 feet or 10%

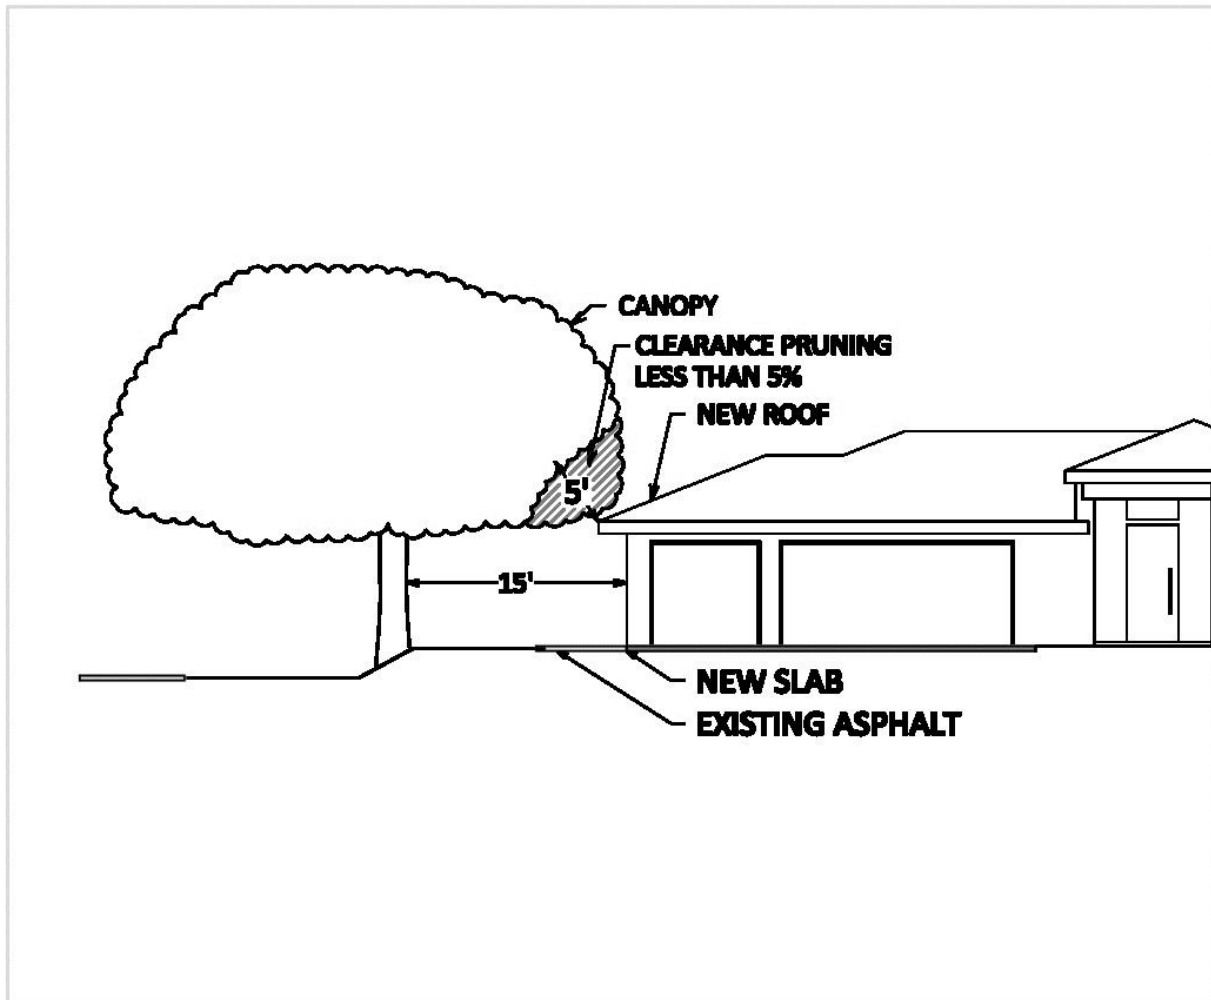
Figure 2 Spatial Study Section

Based on the drawings and onsite observations I estimate less than 5% of the foliage will be removed to allow for 5 feet of clearance around the roof corner that penetrates the canopy.

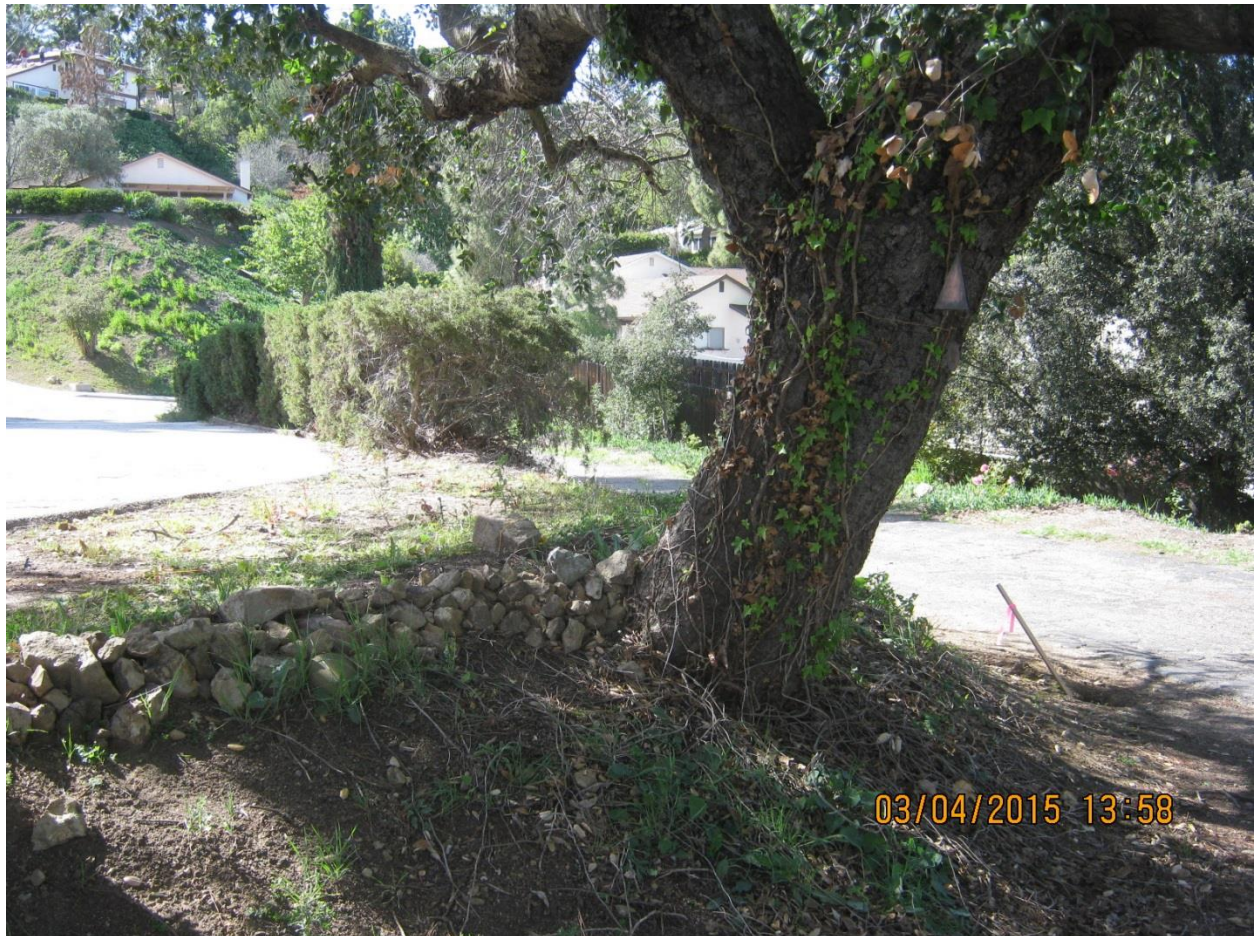
Photo 5

ABOVE: Looking west at the southeast side of the trunk of oak tree #1. Notice that the ivy groundcover is growing up the tree, the vines are woods to ½" diameter.

- Prune to provide 7'-6" clearance above the driveways as described in the Pruning Specifications, Appendix D.
- Remove the English ivy that is choking the oak tree.

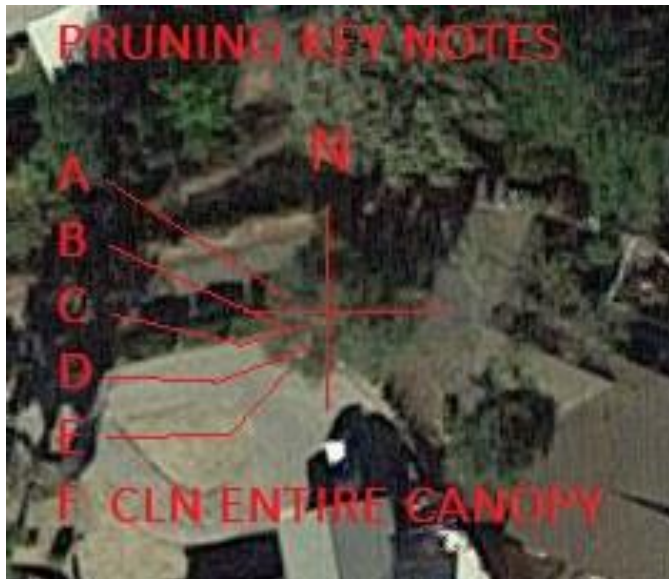
Tree 1- Image 1 Pruning Key Notes

Above: looking at an aerial image of oak tree #1. Lines from the Pruning Key Notes point to the location within the canopy where the note applies. Locations are described by octant or eighths based on the eight compass locations used in this evaluation. Notes are described below:

- A. Remove dead branch (3-1/2" diameter) where it joins 6" branch in the W-NW octant
- B. Remove dead branch stub (3" diameter) in the W-SW octant
- C. Remove a 1" crossing branch originating near the center of the canopy in the W-SW octant and growing east
- D. Remove four (4) dead branch stubs growing from the same 8" scaffold branch.
- E. Reduce the canopy in this area to provide clearance for the proposed roof by five (5') feet. Nearly all the foliage to be reduced comes from the same 8" scaffold branch. Encourage branches that will grow to clear the proposed roof by 5'. To accomplish this clearance, do not remove any live branches over 2" diameter and do not remove more than 5 percent of the oaks total living foliage.
- F. Clean the canopy of all dead wood over 1" diameter and remove the vine that is growing on the tree.
