Protected Tree Report

M.B. Client Center

22001 Nordhoff St

July 19, 2014

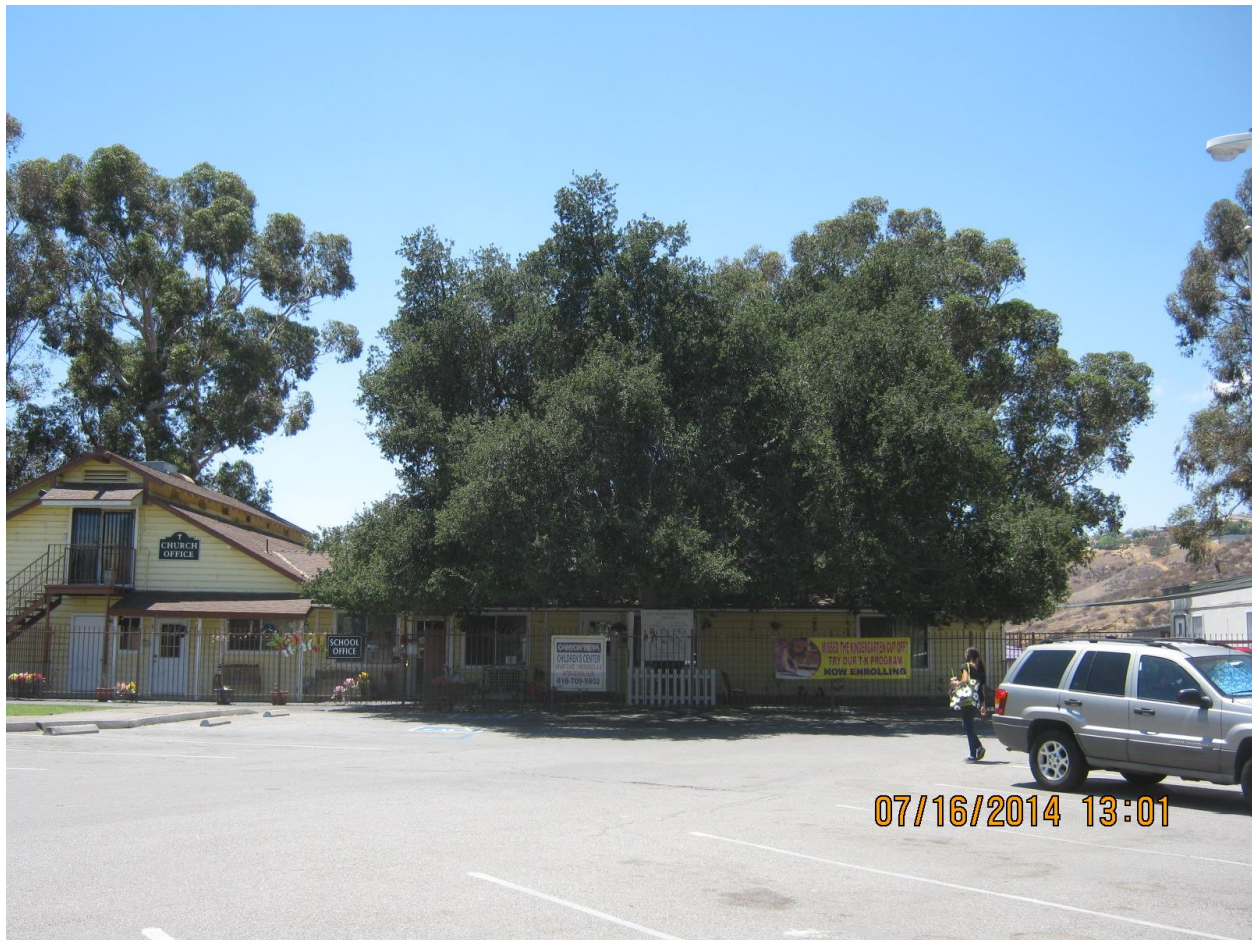
Above looking west at tree 51 Quercus agrifolia.

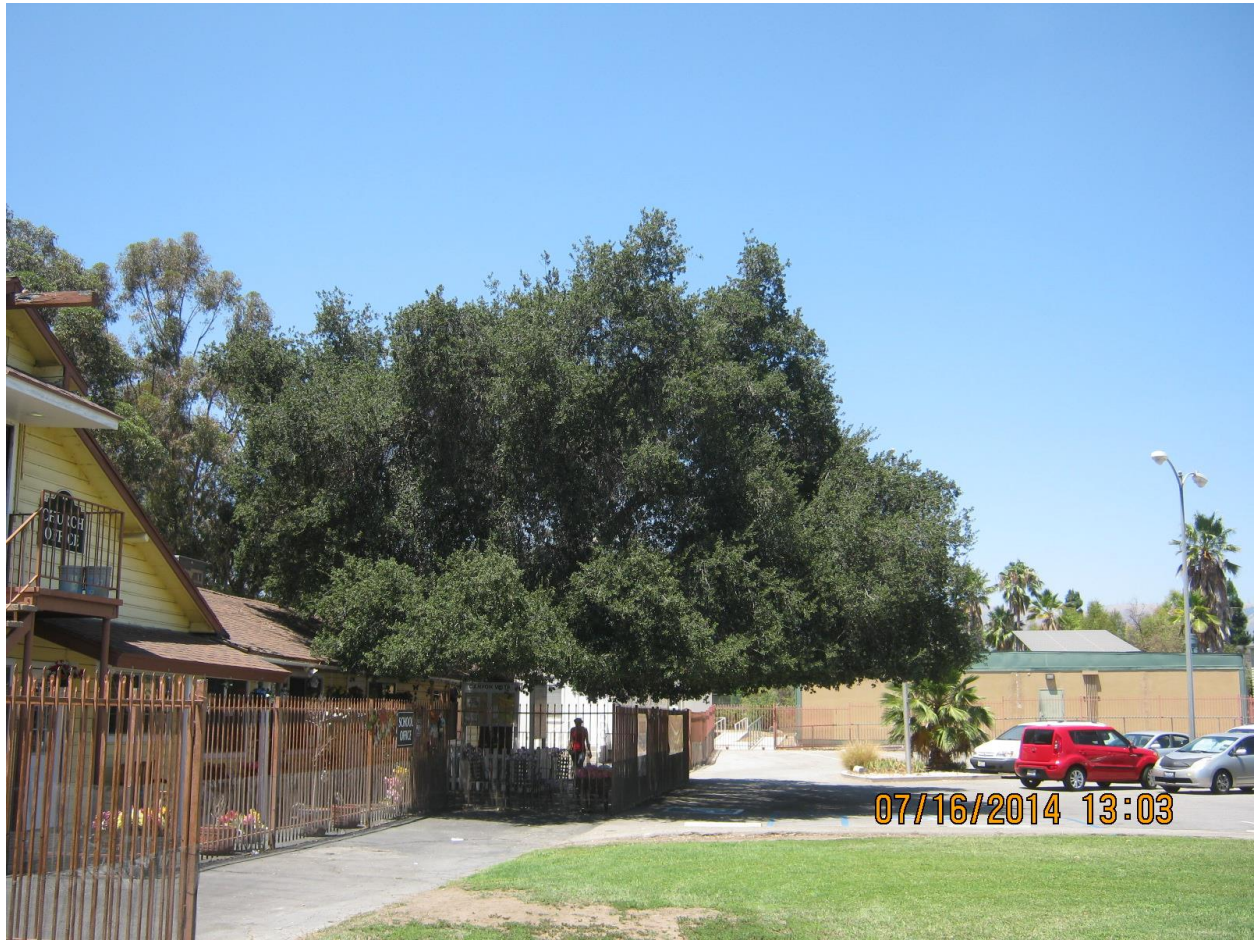
Above looking north at tree 51 *Quercus agrifolia*.

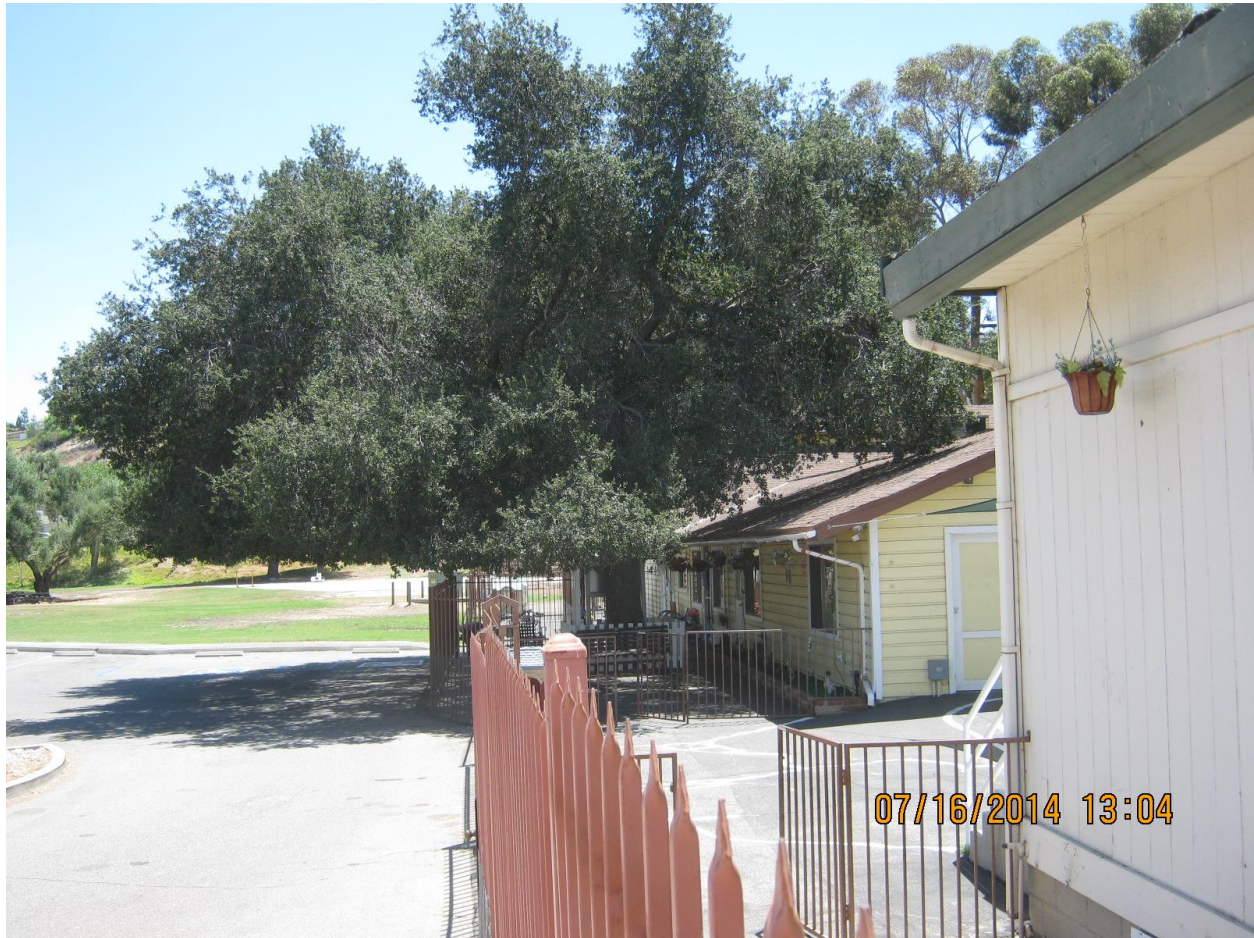
Above looking south at tree 51 Quercus agrifolia.

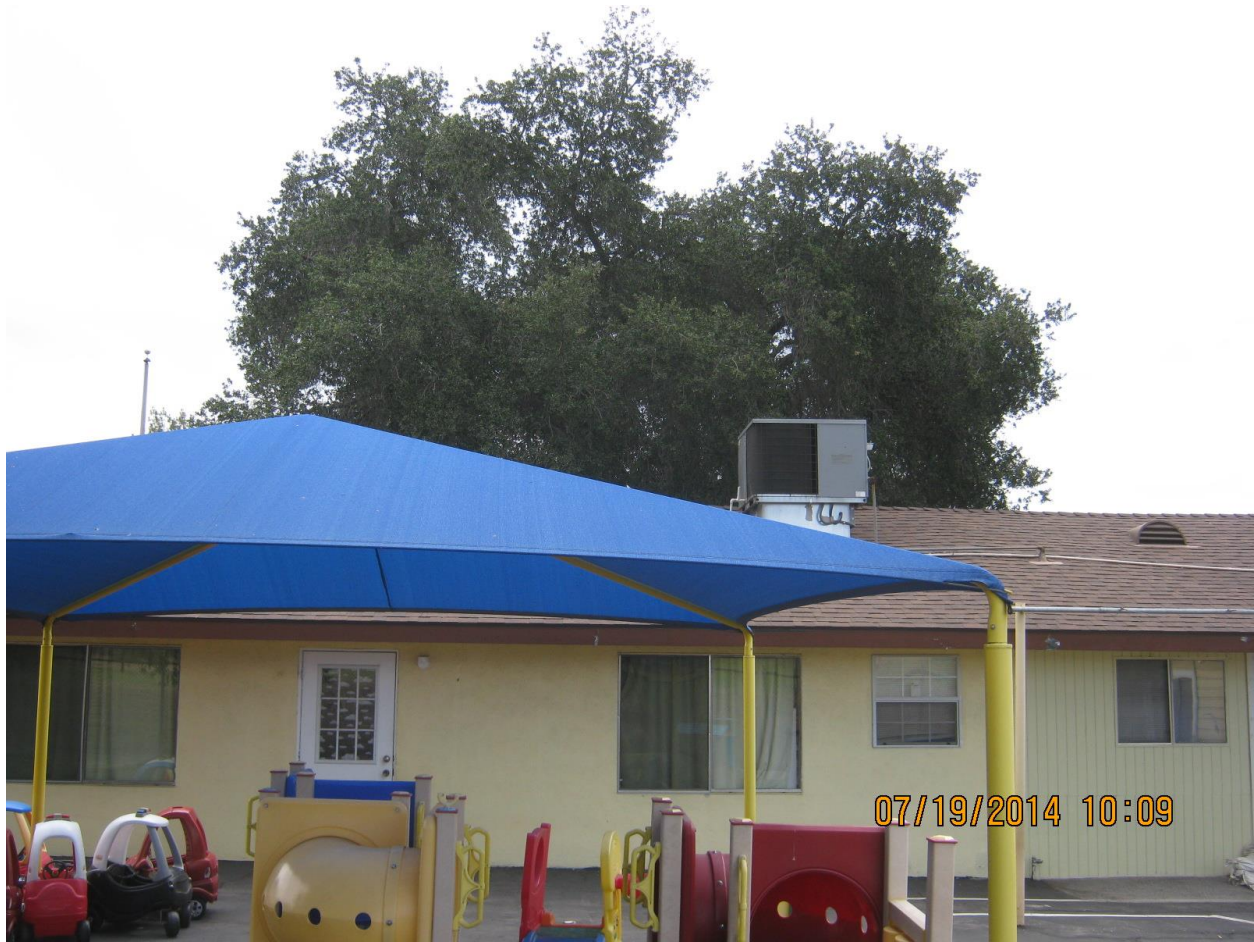
Above looking east at tree 51 *Quercus agrifolia*.

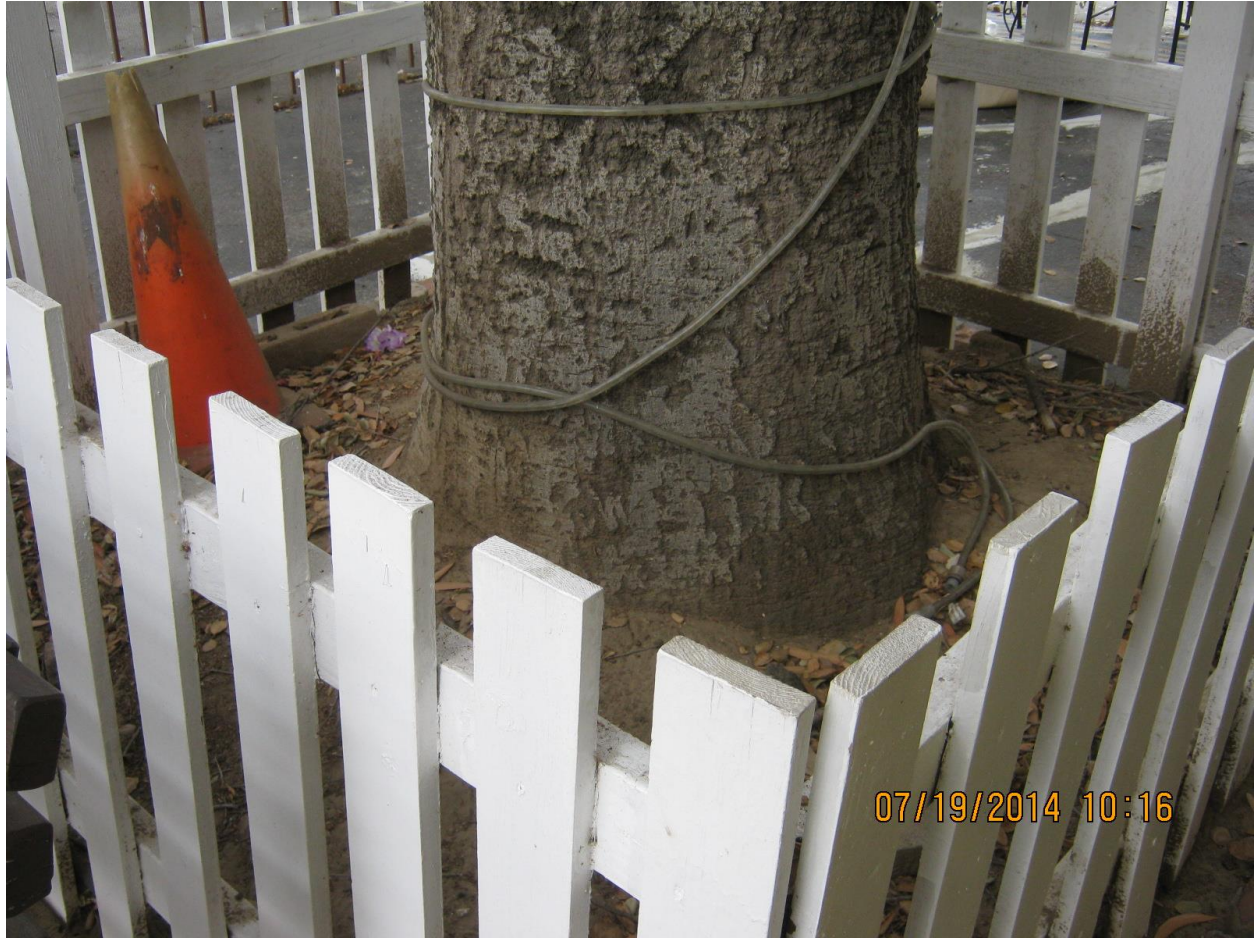
About 6 inches of soil has been placed over the trees root crown.

Above looking trunk of tree 51 *Quercus agrifolia*.

The fill covering the root crown of the oak tree should be carefully removed using hand tools taking care not to damage the trunk or roots.
