Tree Report for
Tree Appraisal Report for Development Permit

Best Avenue
Southern, California

May 2, 2015

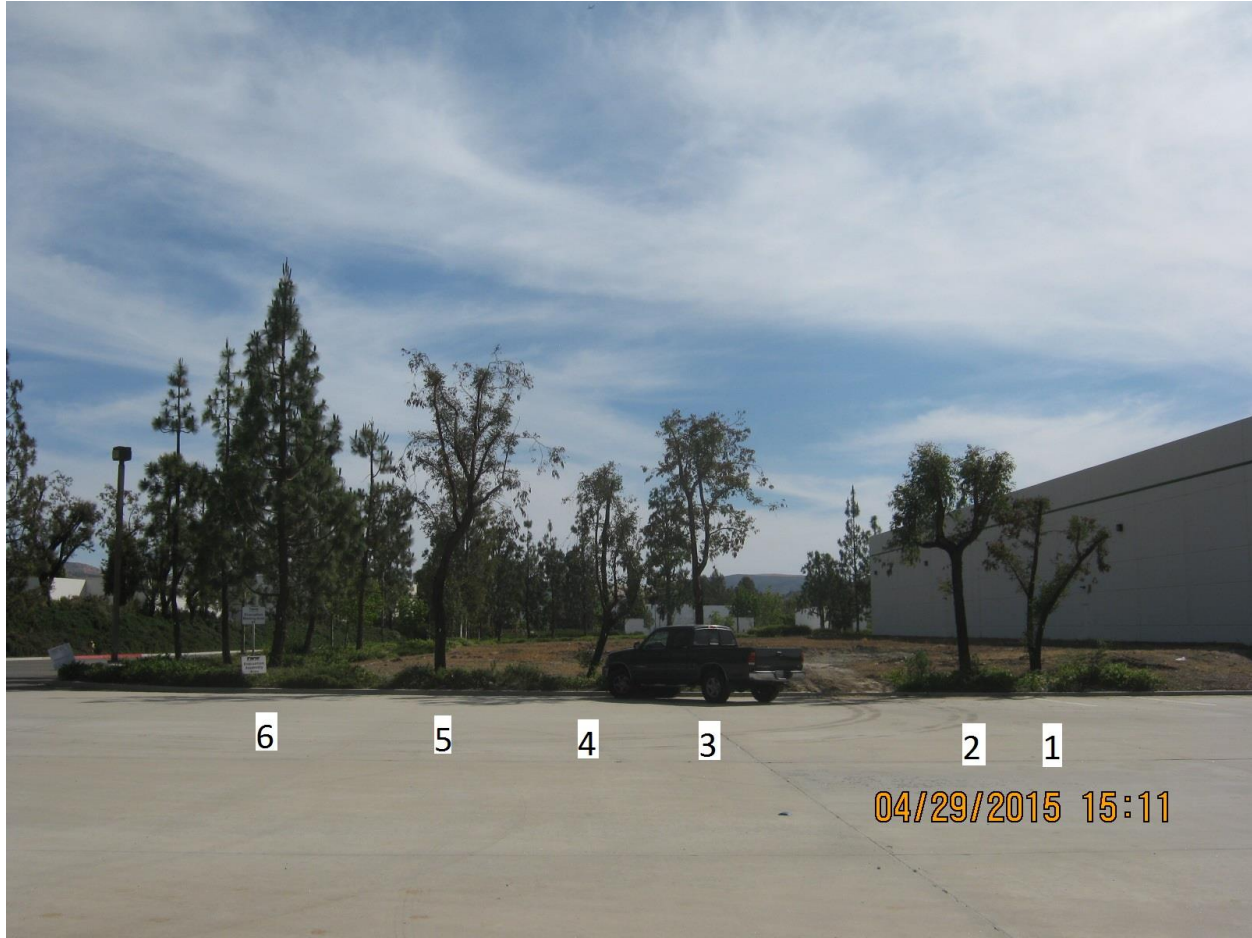
Trees 1-6

Above looking southwest.

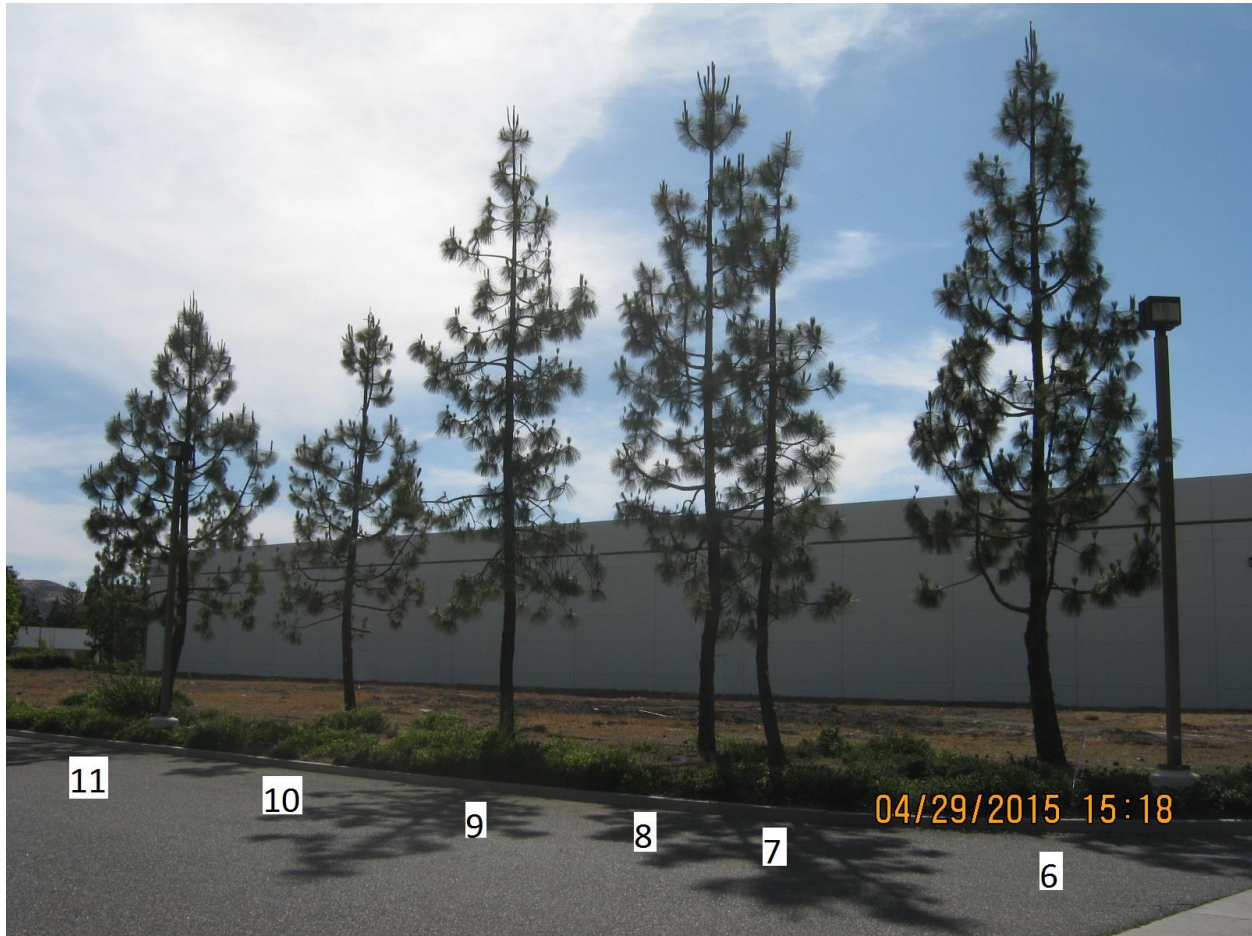
Trees 6-11

Above looking west.

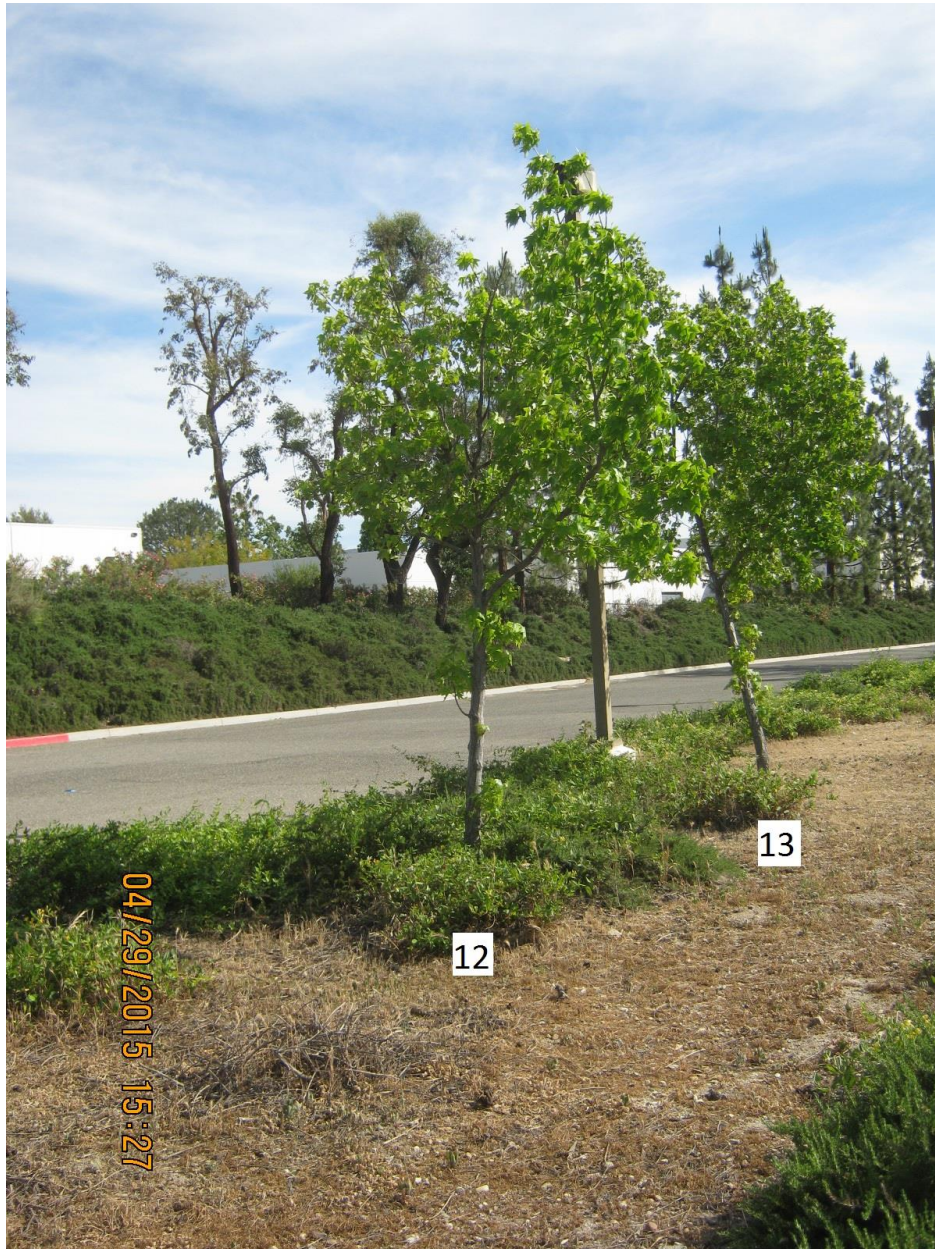
Trees 12-13

Above looking south.

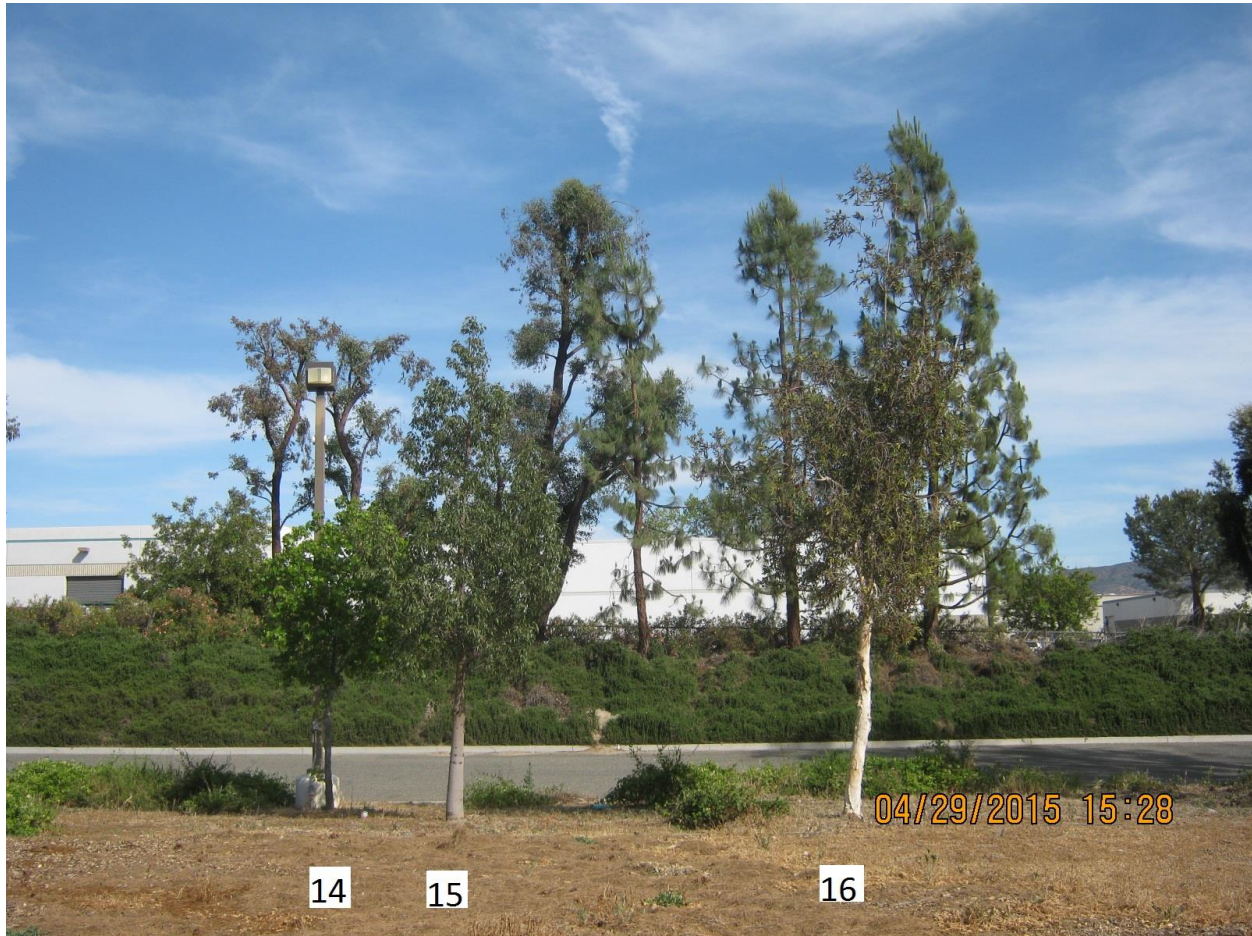
Trees 14-16

Above looking southeast.

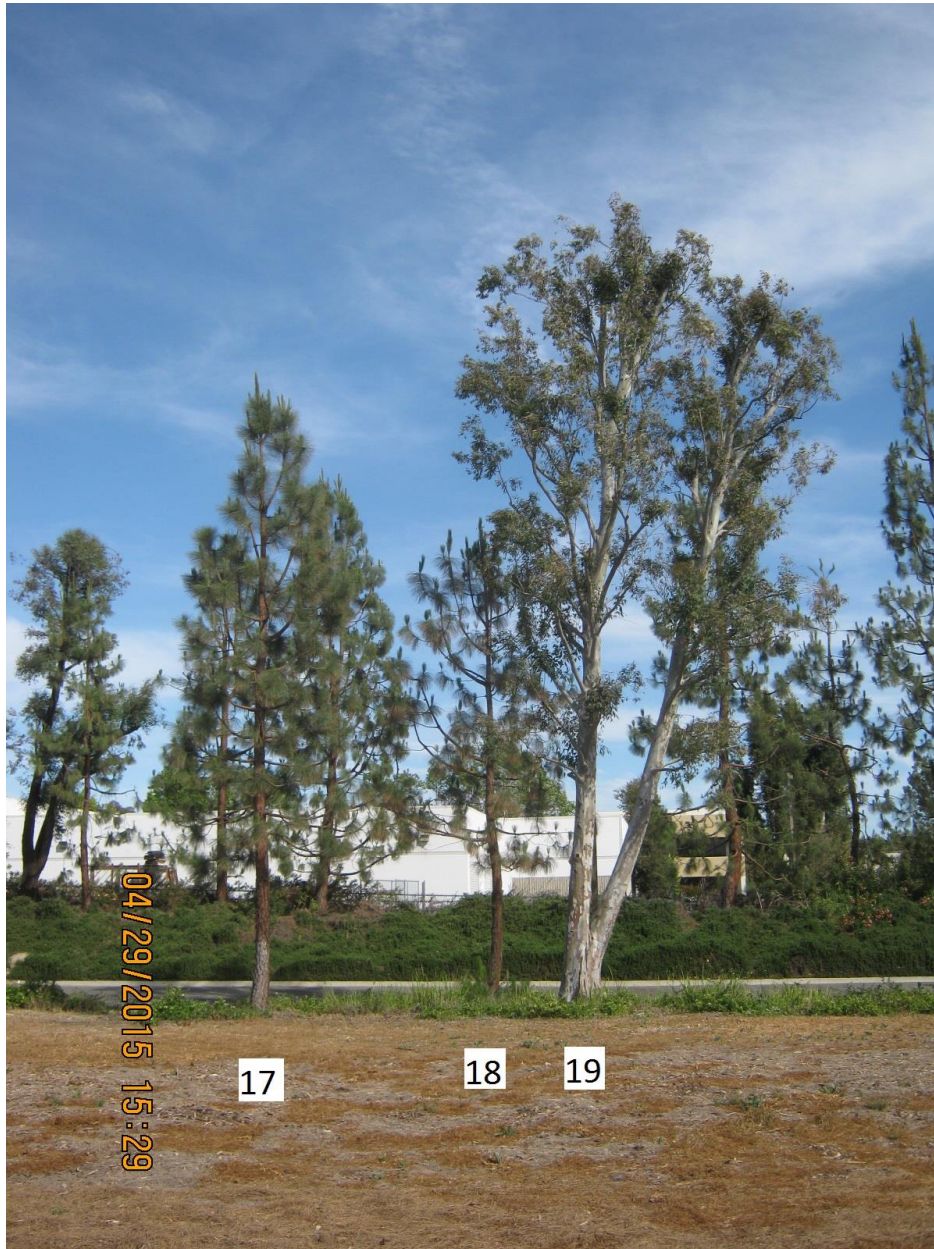
Trees 17-19

Above looking southeast.

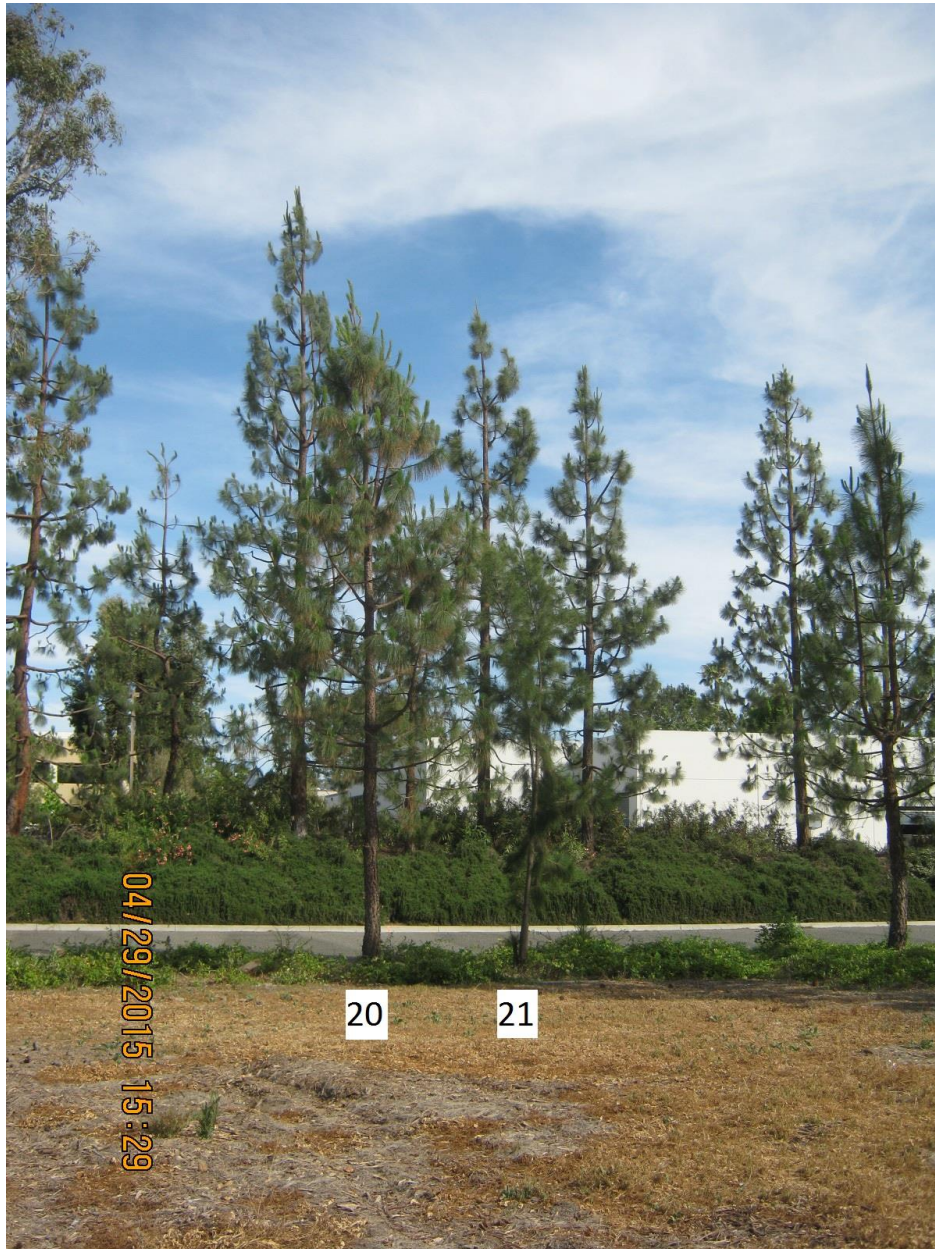
Trees 20 - 21

Above looking southeast.

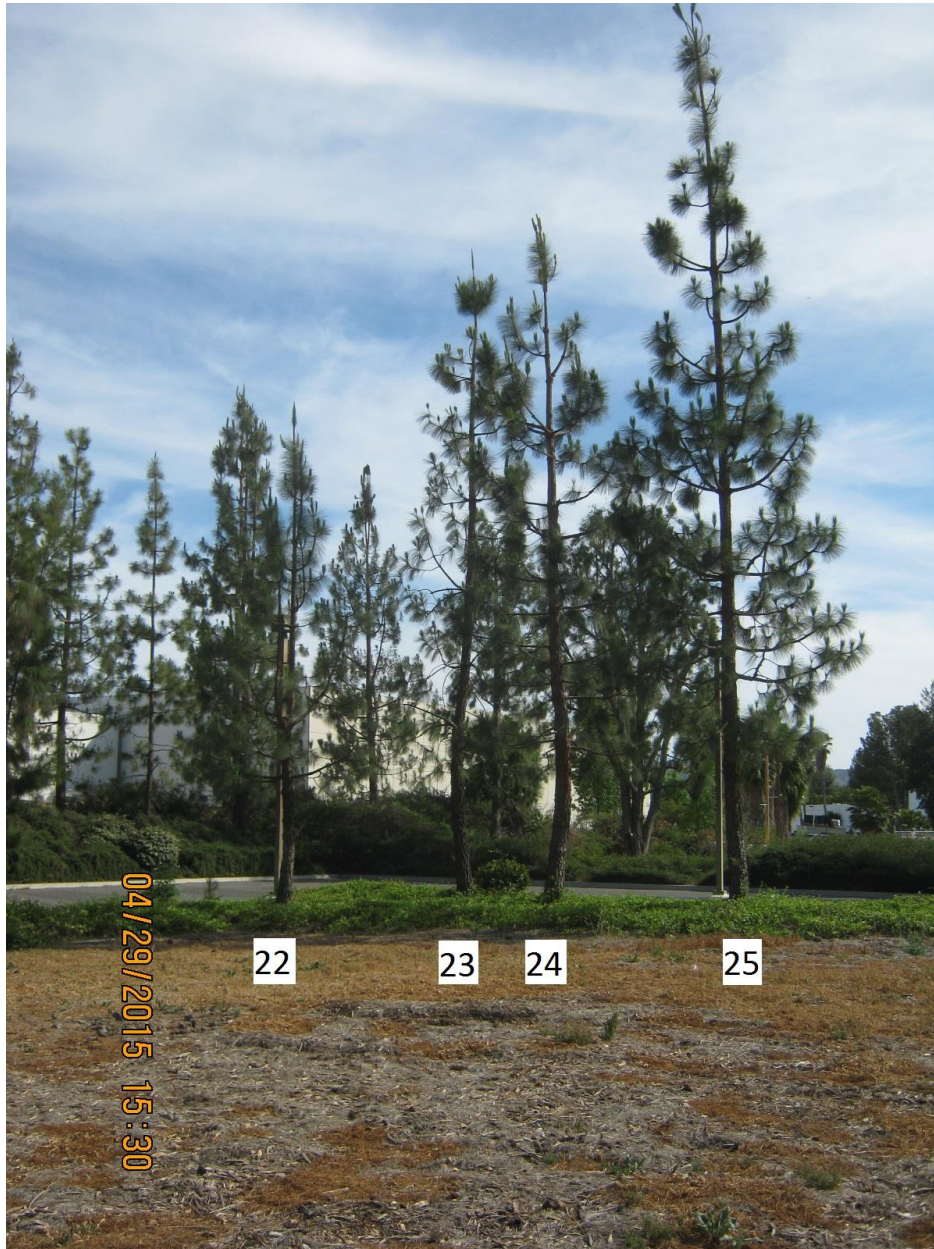
Trees 22- 25

Above looking southwest.

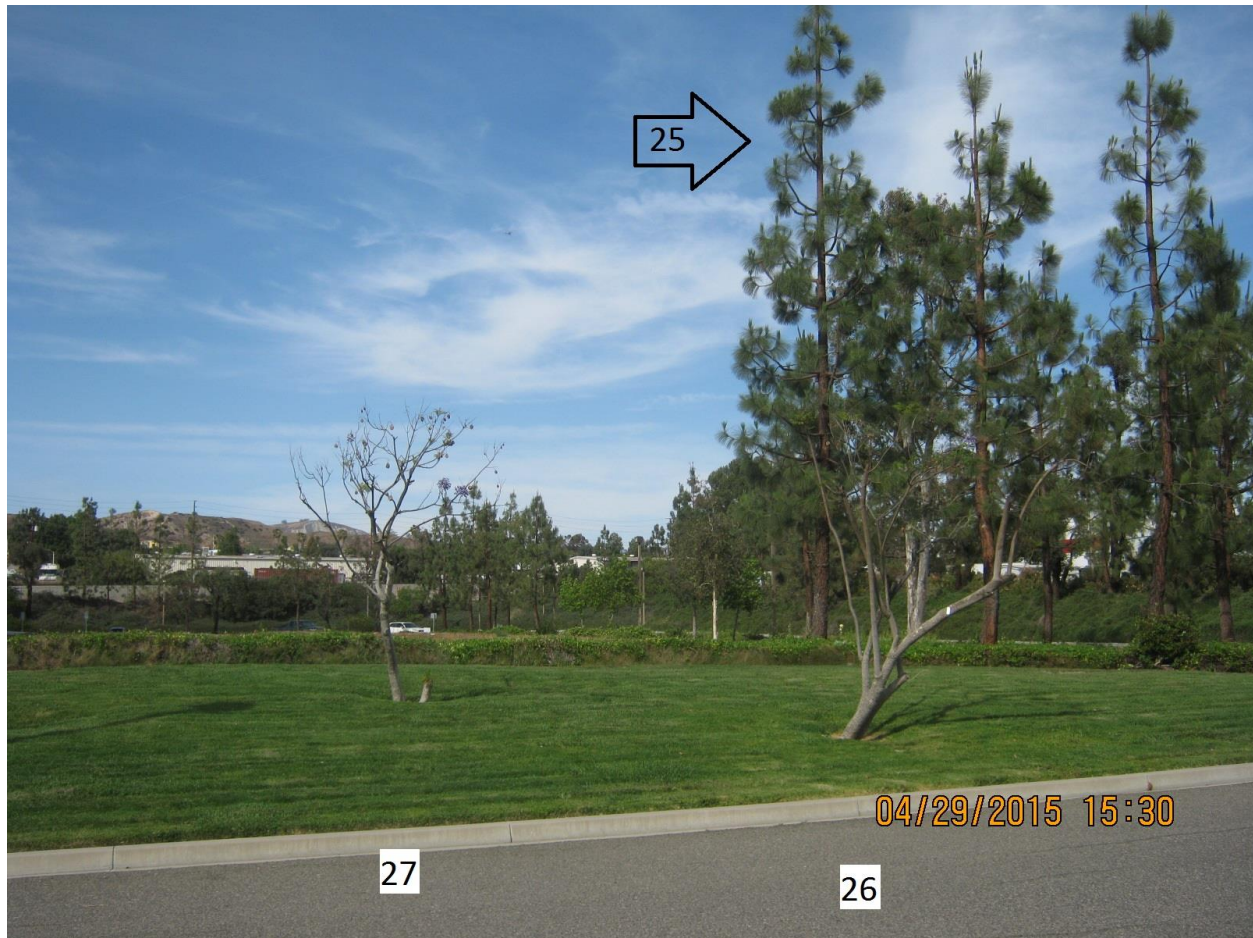
Trees 26- 27

Above looking northeast.

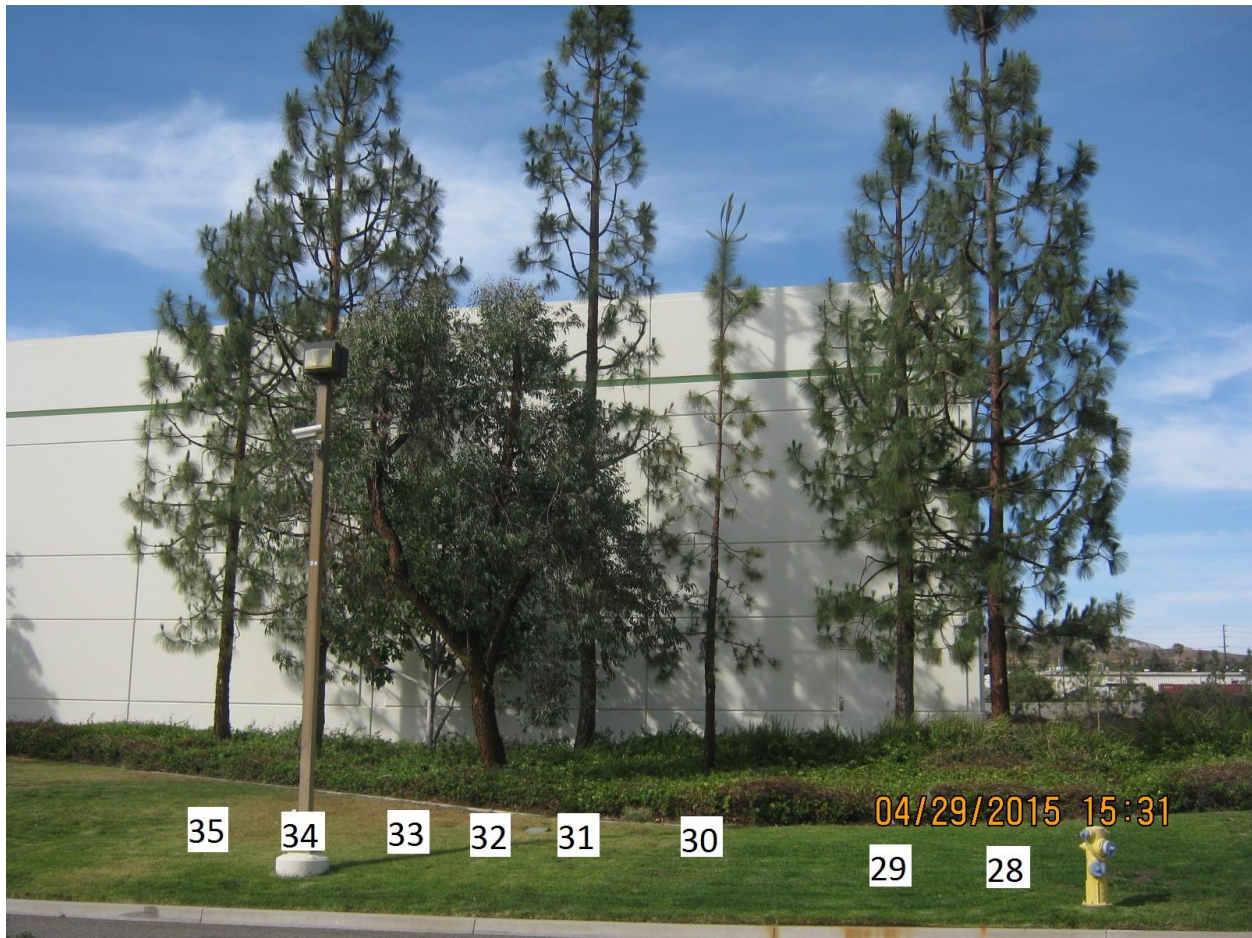
Trees 28- 35

Above looking northeast.

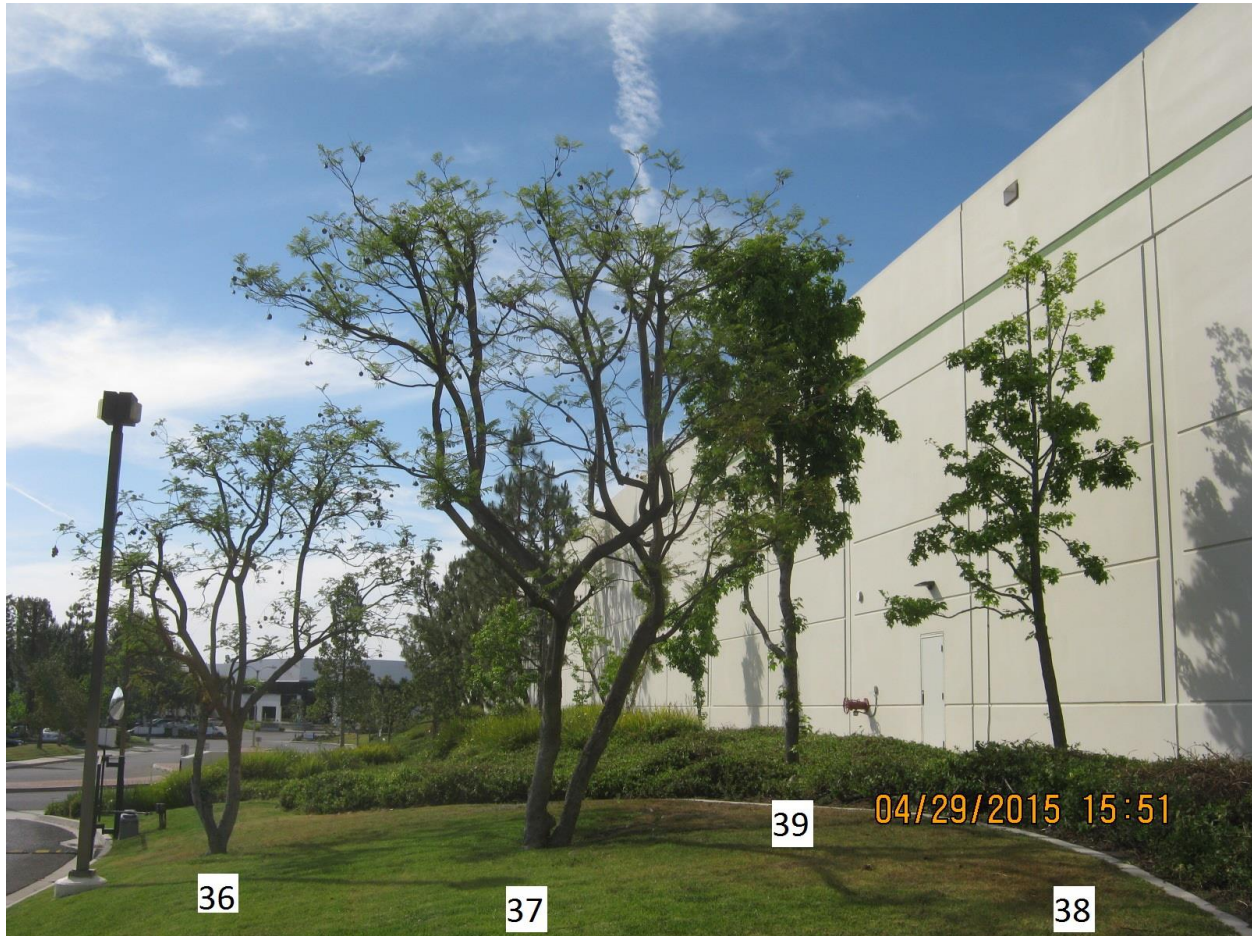
Trees 36- 39

Above looking northwest.
